# Platte River Recovery Implementation Program (PRRIP)

## SYSTEM-SCALE GEOMORPHOLOGY AND VEGETATION MONITORING REPORT

2017 - 2020

**Prepared for: PRRIP Governance Committee**

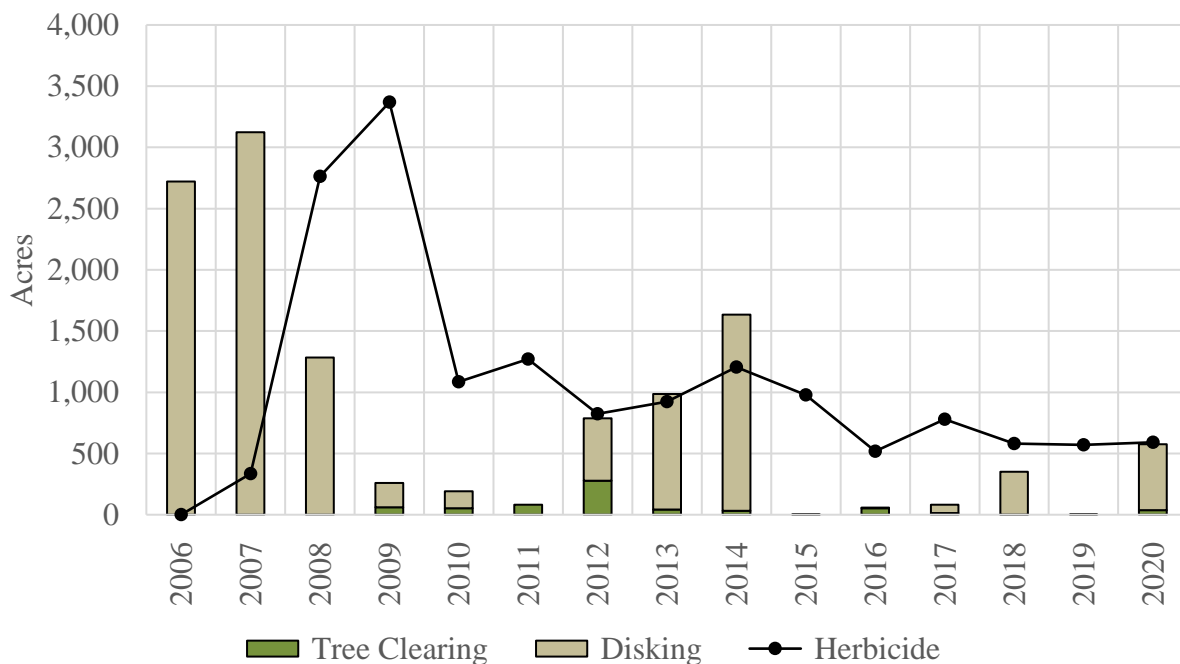
**Figure 3.** Total area of in-channel tree clearing, river channel disking and aerial herbicide application by year for the AHR.

Most mechanical management during the period of 2006 - 2020 was comprised of aerial herbicide application and disking with tree clearing occurring on a much smaller scale (Figure 3). The period of 2006 – 2009 coincided with the end of a historic drought in the basin and the associated proliferation of *Phragmites* into the river channel. Aerial herbicide application to control *Phragmites* began in 2007, peaked in 2009, and has been relatively constant since 2016 at approximately 500 acres per year. We hypothesize that this is the baseline level of treatment that is necessary to prevent *Phragmites* from reinfesting the channel. It is not certain whether baseline effort will need to increase during dry periods or if the continual annual control effort has normalized the amount of treatment for all year types.

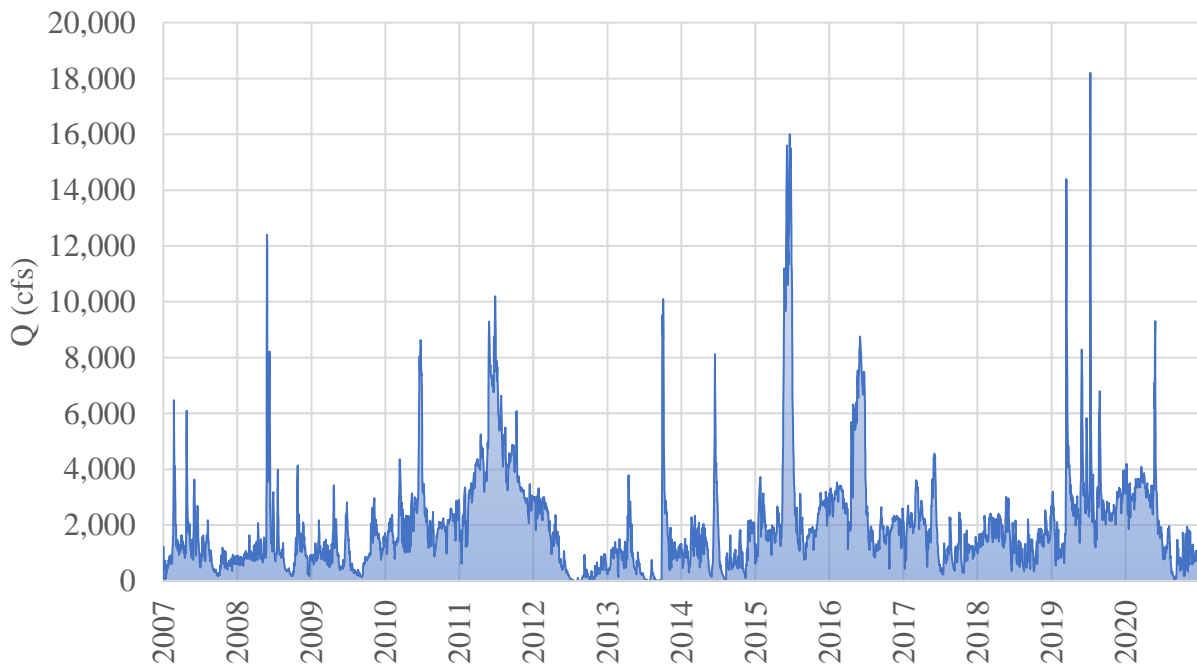
**Figure 4.** Mean daily discharge at the USGS Grand Island (06770500) gage.

Mean daily peak discharge since initiation of system-scale monitoring ranged from a low of 2,960 cfs at Overton in 2018 to a high of 18,200 cfs at Grand Island in 2019 (Table 4 and 5). The 2019 Grand Island peak had a 24-year return interval. Other notable peaks included a long-duration peak in 2011 with an approximately 5-year return interval and 2013 and 2015 peaks with 15-year return intervals. Notably, all large peaks occurred in late spring except for the 2013 event which occurred in the fall due to a historic precipitation event in the upper South Platte basin. The median of the mean daily peak discharge for the reporting period is approximately 8,700 cfs.

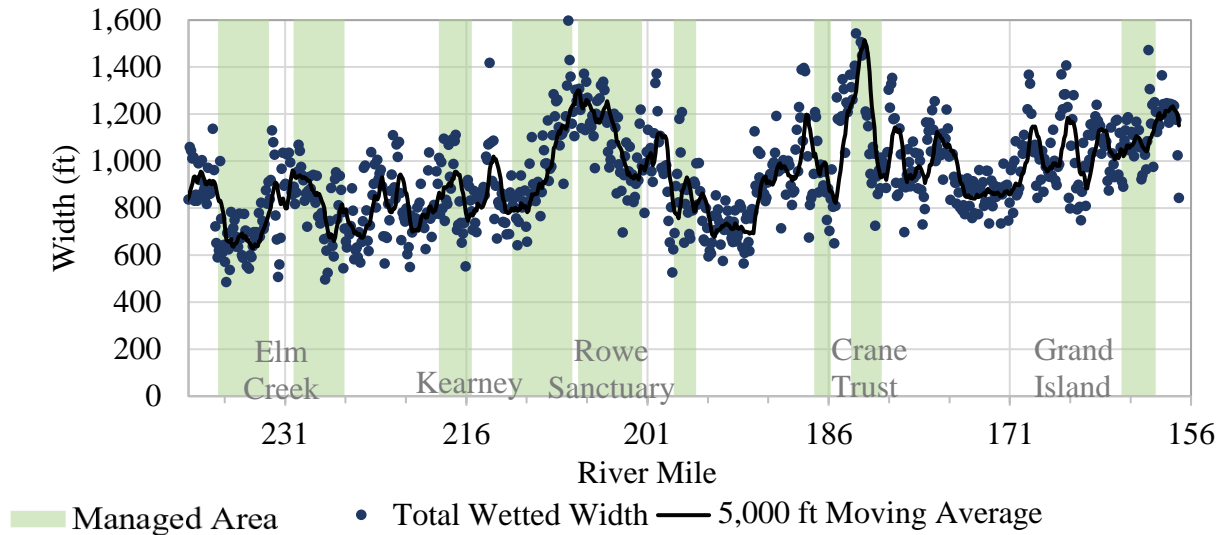
**Figure 6.** All channels wetted width, as sampled at 500 ft transect intervals from the 2000 cfs 2020 hydrodynamic model.

A plot of the 2020 modeled wetted width of all channels at 2,000 cfs (Figure 6) indicates that width is highly variable throughout the AHR but generally increases in a downstream direction. A plot of the 2020 modeled wetted width of the main channel (Figure 7) does not show the same increasing downstream trend, in part because wetted width of the main channel is strongly influenced by the proportion of flow that is consolidated into the main channel at any given location.

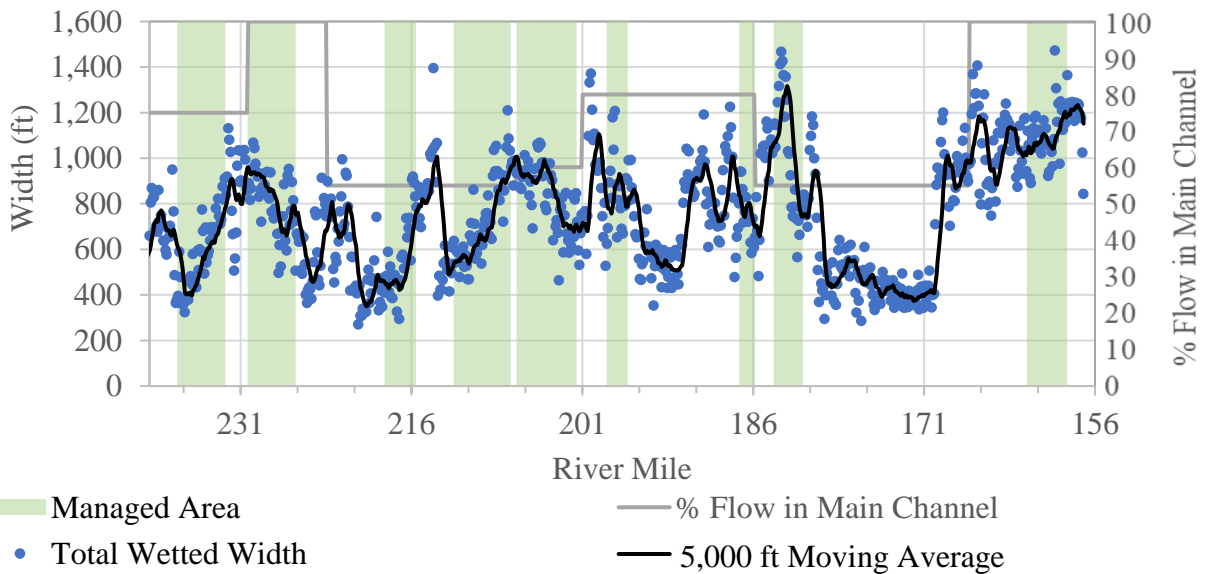
**Figure 7.** Main channel wetted width, as sampled at 500 ft transect intervals from the 2000 cfs 2020 hydrodynamic model.

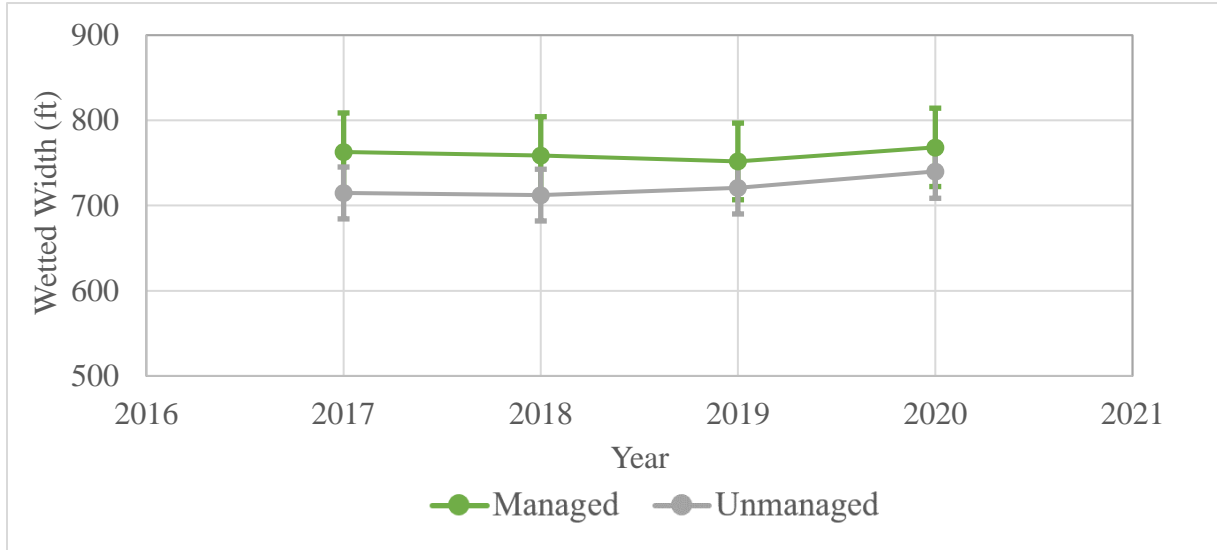
**Figure 8.** Mean (points) and standard error (bars) of wetted width over time from Overton to Chapman in areas of the main channel managed to reduce in-channel vegetation (managed) and other main channel areas (unmanaged). Data are sampled at 500 ft transect intervals from the 2000 cfs 2020 hydrodynamic model.

Comparing managed areas to other areas of the main channel provides a cursory indication of the effect of management on morphology. Managed areas have, on average, slightly higher width, lower depth, and a higher width:depth ratio than other areas. However, the differences are small. The differences in wetted width are well within the bounds of the standard error of the distribution (Figure 7). The 2019 floods did not appear to substantially change channel hydraulics. However, in 2019, managed areas did experience a small increase in average depth and corresponding decrease in the width:depth ratio. Overall, year-to-year differences are small and indicate that the morphology of the AHR did not change substantially from 2017-2020.

When making sediment balance comparisons between years, it is important to note that the higher uncertainty values in wet areas in 2019 reduced the total area that met the significance threshold necessary for inclusion in the analysis. Nevertheless, a signature from the 2019 floods is evident when significant elevation differences are classified (Figures 28 - 30). 2019 saw an increase in both the area of aggradation (Figure 29) and the volume of lateral erosion (Figure 30). Bed degradation did not increase in 2019 in correspondence with the rate of aggradation. This indicates that the dominant sediment dynamic during the floods was lateral erosion and subsequent deposition of eroded material, rather than general bed erosion. The elevated magnitude of lateral erosion volume in 2019 (Figure 30) suggests that certain areas of the channel experienced widening. This is reflected in a slight (non-significant) increase in wetted width at the AHR-scale (Figure 8).

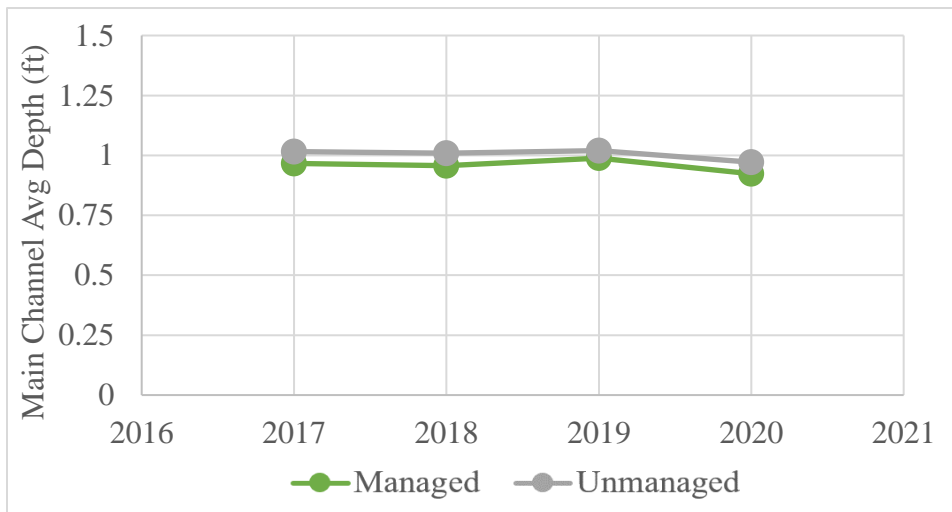
**Figure 9.** Mean depth over time from Overton to Chapman, from the 2000 cfs 2020 hydrodynamic model in areas of the main channel managed to reduce in-channel vegetation (managed) and other main channel areas (unmanaged).

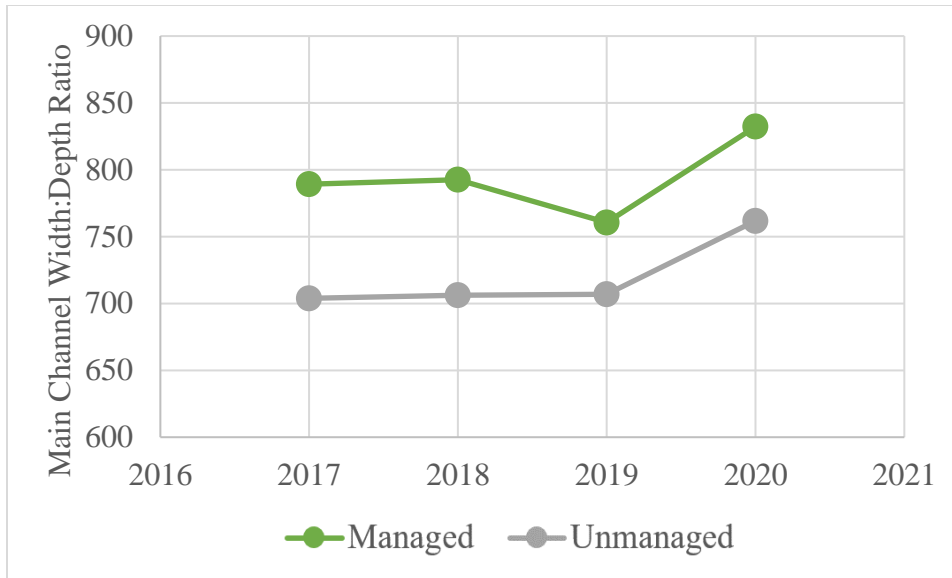
**Figure 10.** Width:depth ratio over time from Overton to Chapman, from the 2000 cfs 2020 hydrodynamic model in areas of the main channel managed to reduce in-channel vegetation (managed) and other main channel areas (unmanaged).

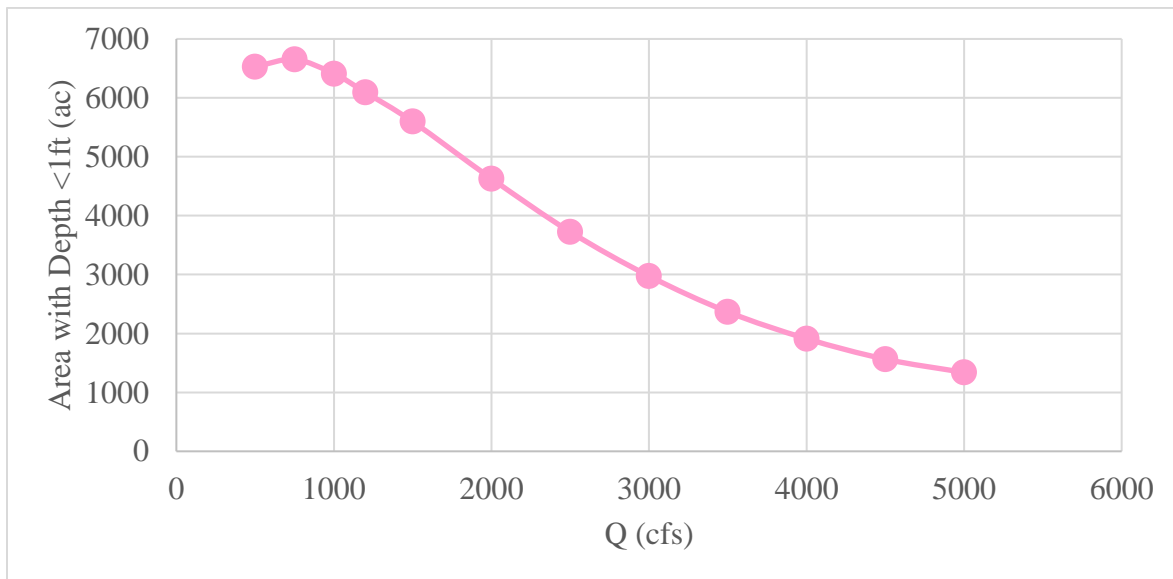
**Figure 11.** Total channel area from Overton to Chapman with depth less than 1 ft, as estimated with the 2020 hydrodynamic model.

The modeling results also allow for the examination of the area of channel with depth less than 1 ft, which is an important component of WC roosting habitat. Results indicate that the area of shallow channel is maximized at a flow of 750 cfs (Figure 11). At 2,000 cfs, the percentage of the total channel area < 1 ft deep was slightly higher in managed areas (Figure 12). Shallow channel area increased every year in managed areas and did not appear to be strongly influenced by the 2019 floods. Shallow channel area did not increase as much in unmanaged areas.

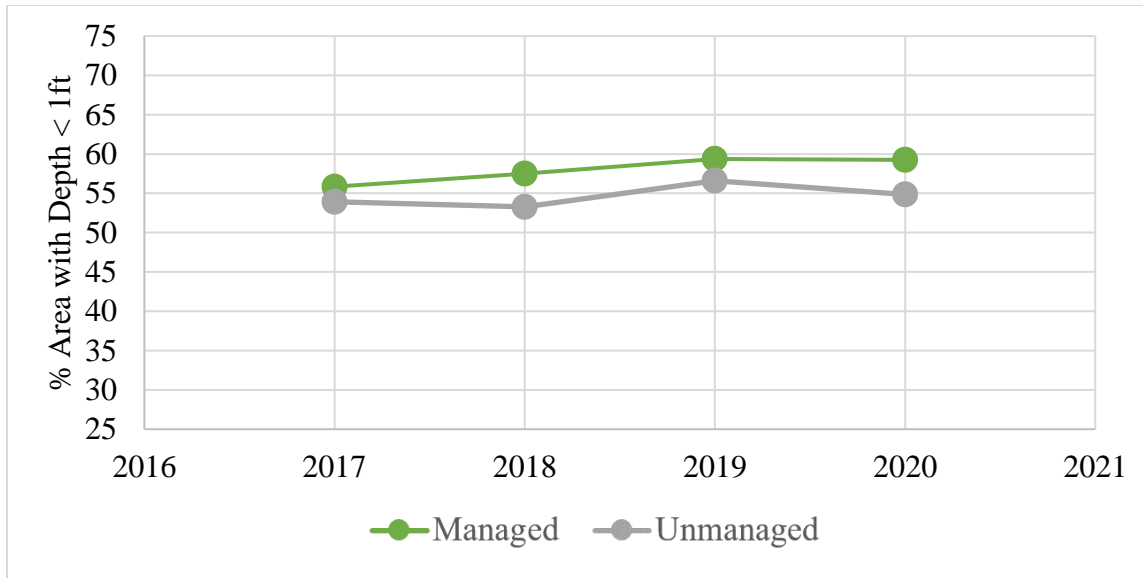
**Figure 12.** Percentage of channel area with depth less than 1 ft at 2000 cfs in areas of the main channel managed to reduce in-channel vegetation (managed) and other main channel areas (unmanaged) as estimated from 2017-2020.

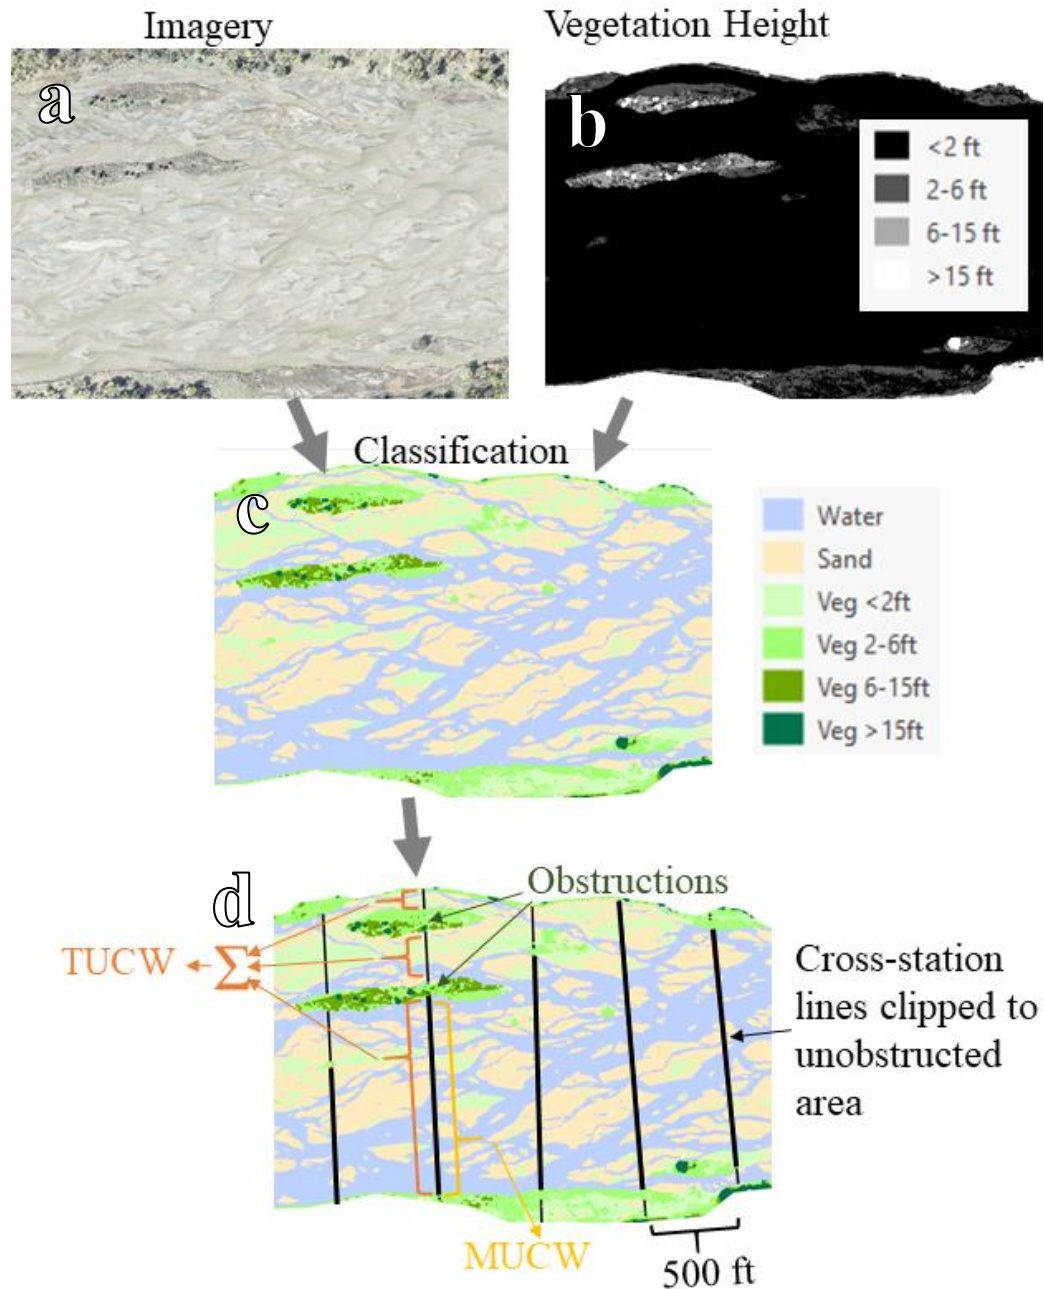
**Figure 13.** Conceptual diagram illustrating the combination of (a) imagery and (b) LiDAR-derived vegetation height data to (c) classify land cover surface. The land cover surface is then used to (d) clip cross-station lines to unobstructed area, calculate MUCW as maximum continuous channel width that is unobstructed by vegetation  $\geq 2$  ft in height, and calculate TUCW as the total of all segments of channel width unobstructed by vegetation  $\geq 2$  ft in height.

Land cover classification was accomplished using Trimble eCognition object-based classification software ([Trimble, 2021](#)). In object-based classification, pixels are grouped into spectrally homogenous objects, and then the objects are classified utilizing user-defined criteria. This method differs from the more traditional pixel-based classification, in which all pixels are classified by their individual spectra ([Burnett & Blaschke, 2003](#)). Object-based classification has been

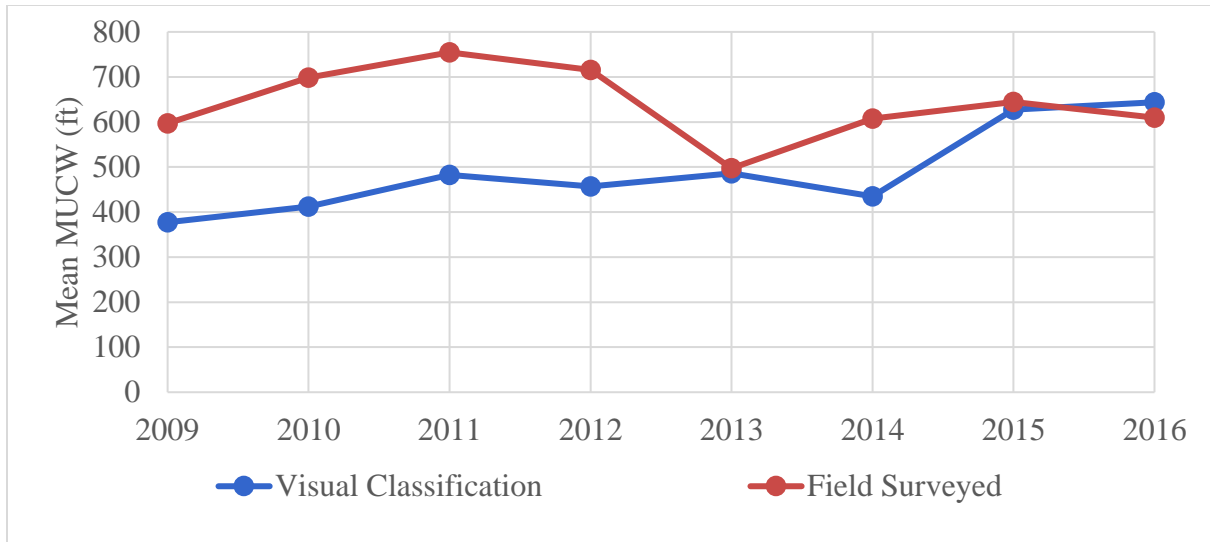
**Figure 14.** Comparison of the mean MUCW over all channels as measured with visual classification and field surveys from 2009-2016.

These discrepancies can be ascribed to several differences between methods including the field survey extending MUCW past the edge of channel into the overbank; the remote sensing visual classification of vegetation height without elevation data; differing delineation of the channel bank location; as well as the limited sample size of the field survey transects compared to the remote sensing transects. Because visual classification is most like the object-based classification in terms of both measurement methods, spatial coverage, and sample size, the visual classification will be used going forward to report channel widths prior to 2017.

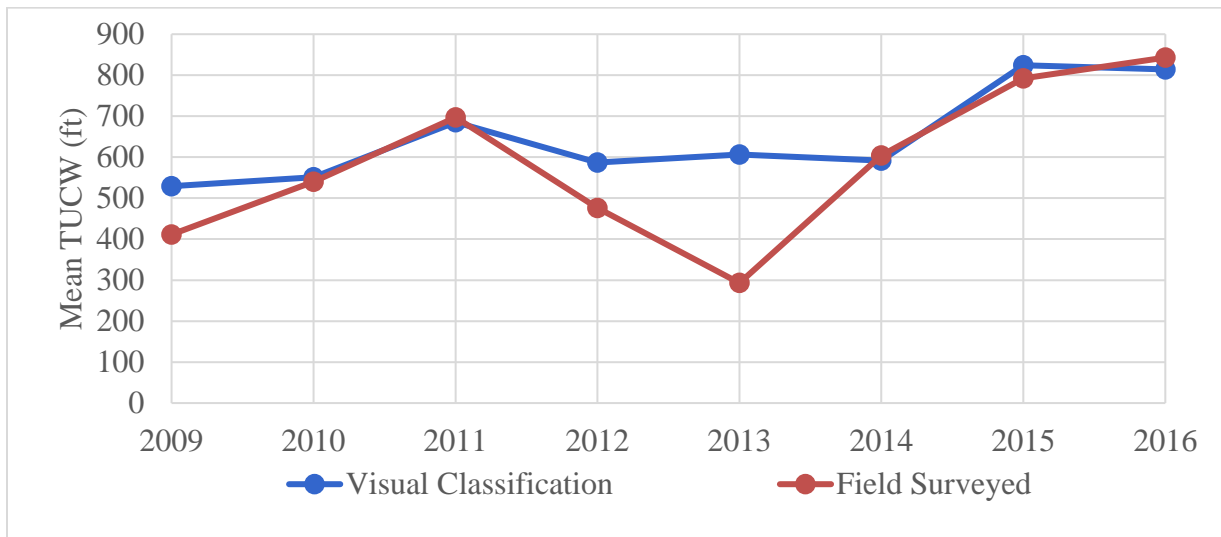
**Figure 15.** Comparison of the mean TUCW of the main channel as measured with visual classification and field surveys from 2009-2016.

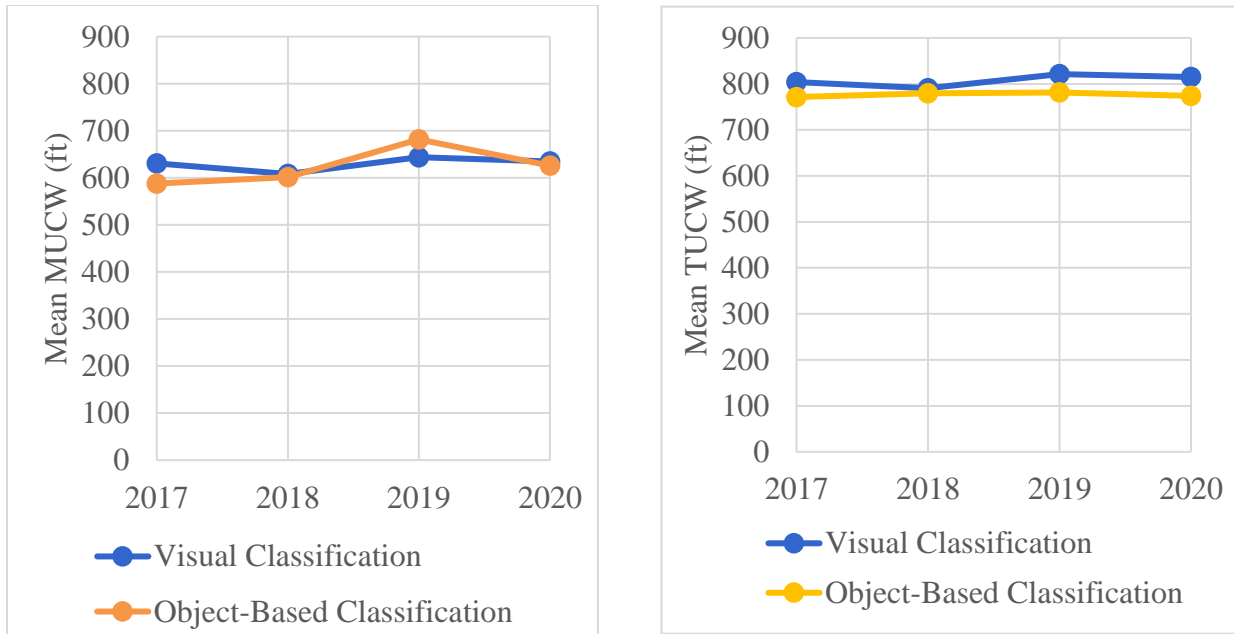
**Figure 16.** Mean MUCW (all channels) values (left) and TUCW (main channel) values (right), as measured with visual classification and object-based classification for the years 2017-2020.

Object-based and visual classification results for MUCW and TUCW were compared for the period of 2017-2020 (Figure 16) to evaluate the similarity of estimates from the two methodologies. Paired t-tests were used to compare results from the two methods using the same subset of originally sampled transects at 5,000 ft spacing to reduce spatial autocorrelation.

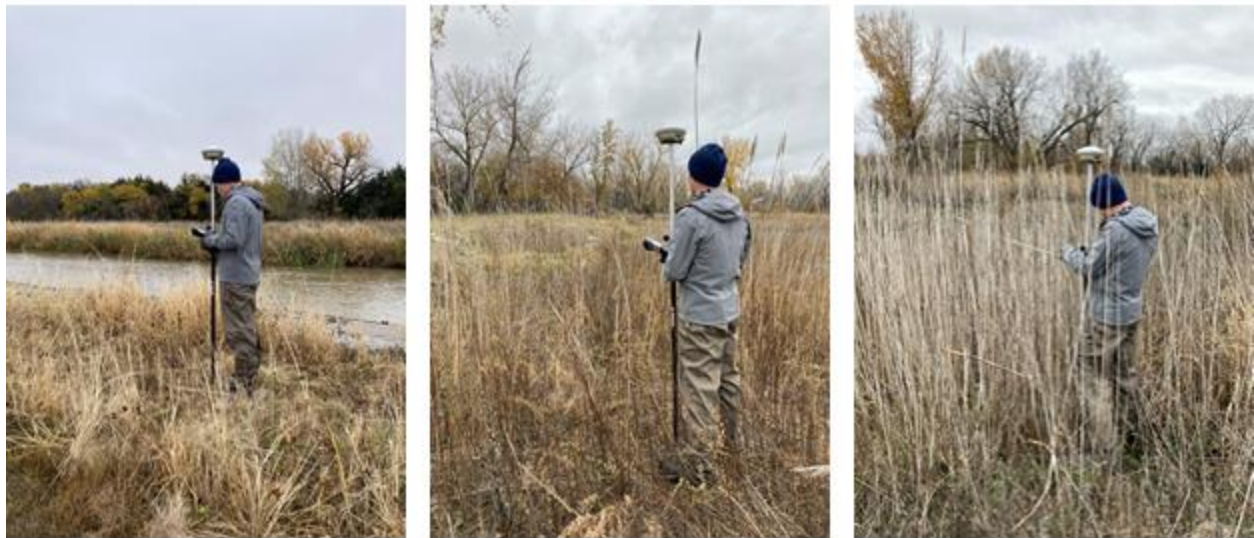
**Figure 17.** Three patches of in-channel grass observed on the Platte in November of 2021 with variable height, density, and color. Researcher is 6 ft tall.

The systematic difference between visual and object-based classification may in part due to the lack of elevation or vegetation height data in the visual classification methods. Visual observers rely primarily on vegetation density to interpret vegetation height. One land cover that exemplifies potential problems with this method is grass. In-channel grasses on the Platte may range from 0-6 ft tall and at any height may be highly variable in color and density (Figure 17). Determining whether each patch is greater or less than 2 ft based on visual interpretation of aerial imagery alone is inherently subjective.

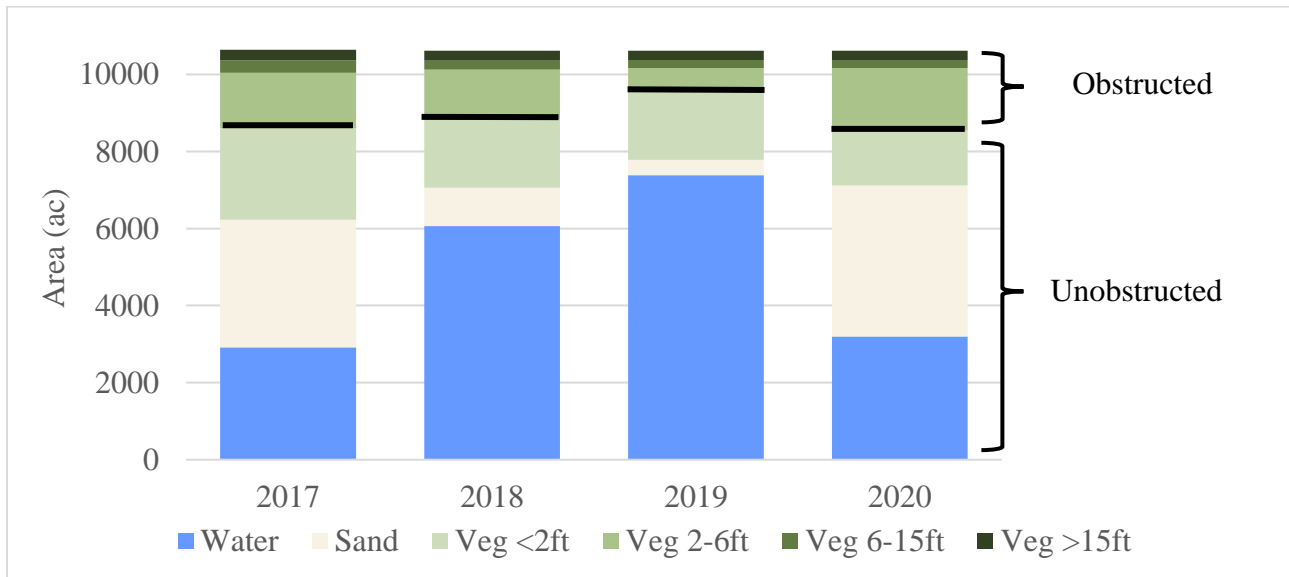
**Figure 18.** Total area of land cover classes in the main channel. Brackets on the right indicate classes that are grouped as obstructed or unobstructed.

In 2020, the coverage of vegetation 2-6 ft in height increased by over 150%, to encompass more area than was observed in 2017-2019. Water, sand, and vegetation less than 2 ft in height simultaneously decreased in coverage, suggesting that vegetation on islands and near-overbank areas recovered quickly from the 2019 flood disturbance.

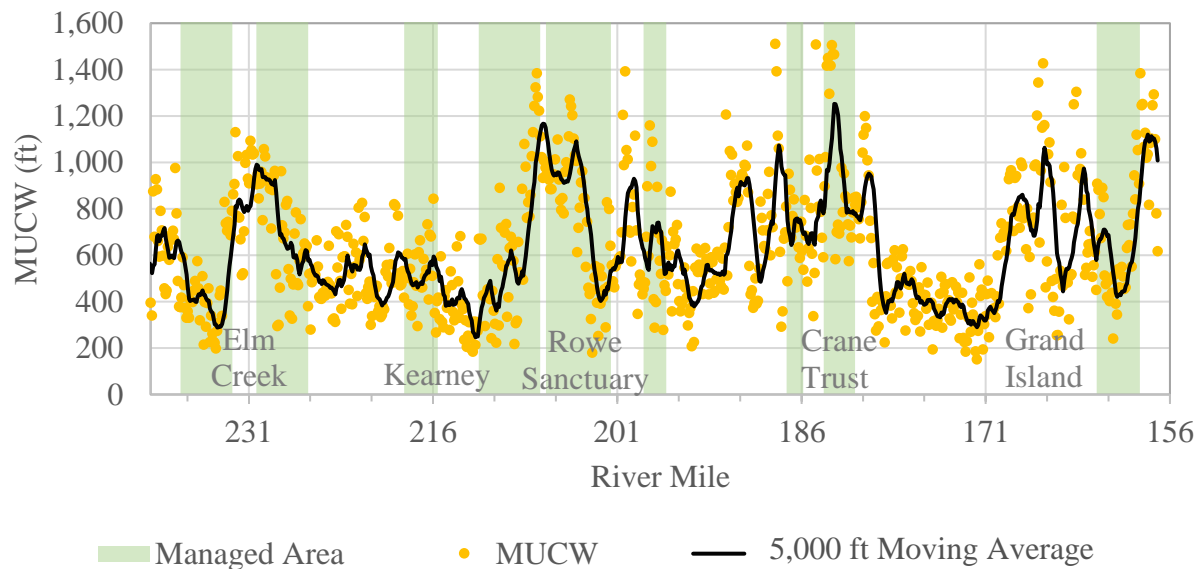
**Figure 19.** All channels maximum unobstructed width (MUCW), as sampled at transects spaced at 500 ft intervals, with a 5,000 ft moving average. Channel areas managed to reduce in-channel vegetation are shaded green.

When plotted by river mile, MUCW (all channels) and TUCW (main channel) (Figures 19 and 20) exhibit a high degree of variability. MUCW is more variable than TUCW due to its higher sensitivity to the location of obstruction within the channel. Small in-channel obstructions can reduce MUCW by hundreds of feet, cutting it in half or more, while impacting TUCW only minimally.

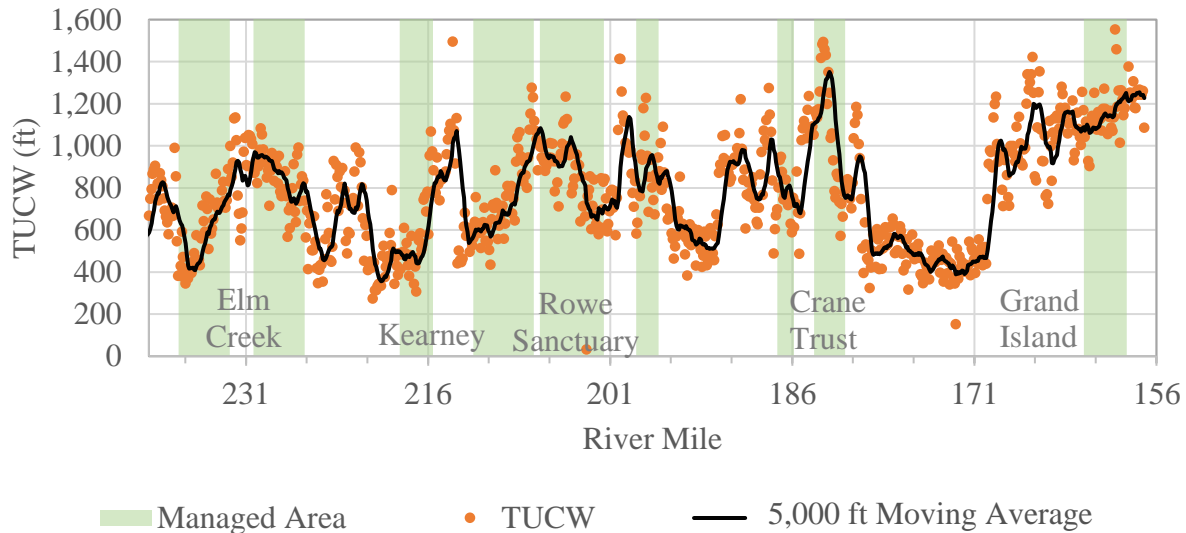
**Figure 20.** Main channel total unobstructed width (TUCW), as sampled at 500 ft transects, with a 5,000 ft moving average. Channel areas managed to reduce in-channel vegetation are shaded green.

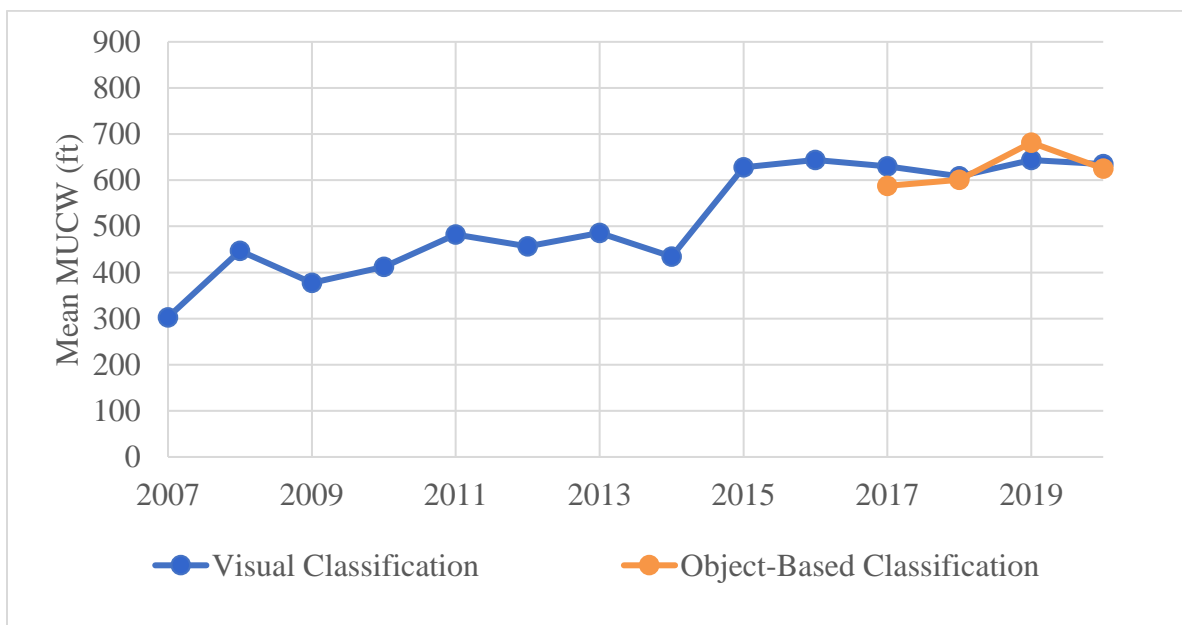
**Figure 21.** Mean MUCW over all channels by year from visual classification of aerial imagery and object-based classification.

When compared to the historical record of mean MUCW (all channels) and TUCW (main channel) values from visual classification (Figures 21 and 22), the period of 2017-2020 was relatively stable. The modest increase in MUCW and TUCW following the 2019 floods (<50 ft) was substantially less than the approximately 200 ft increases in both metrics that occurred in 2015.

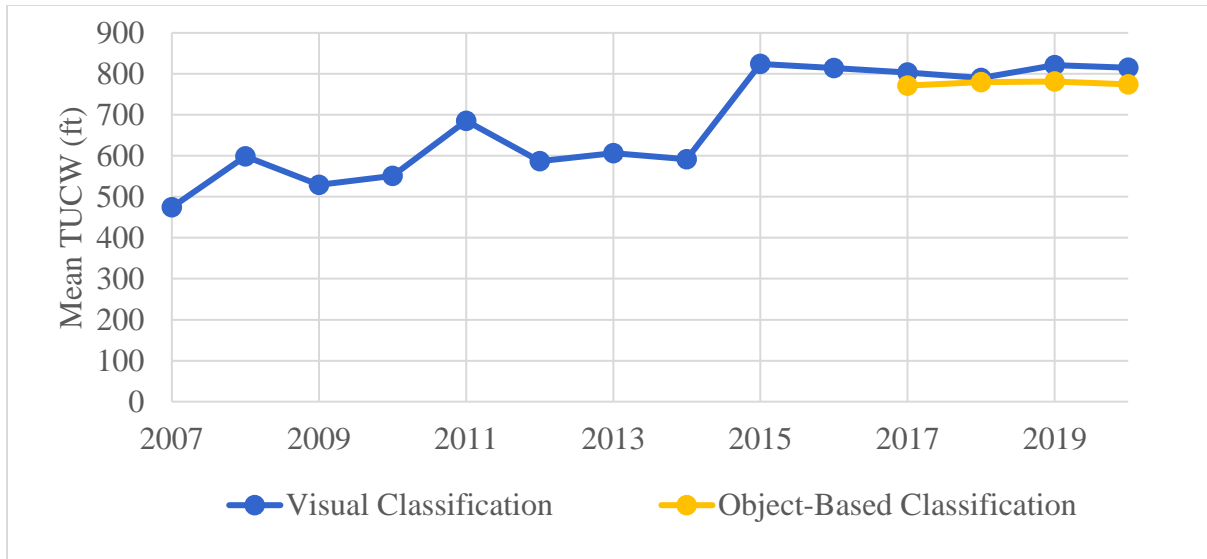
**Figure 22.** Mean main channel TUCW by year from visual classification of aerial imagery and object-based classification.

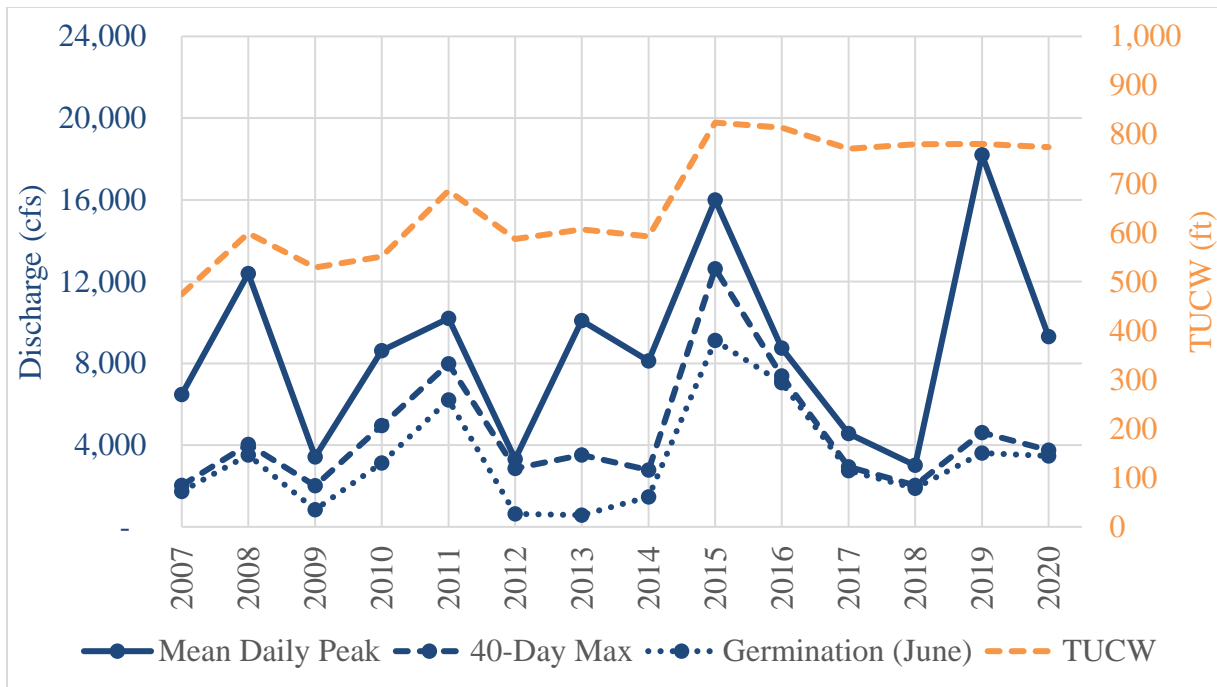
**Figure 23.** Hydrologic metrics and corresponding main channel TUCW as measured with visual classification from 2007 to 2020. Displayed TUCW values were estimated with visual remote sensing from 2007-2016 and object-based classification from 2017-2020.

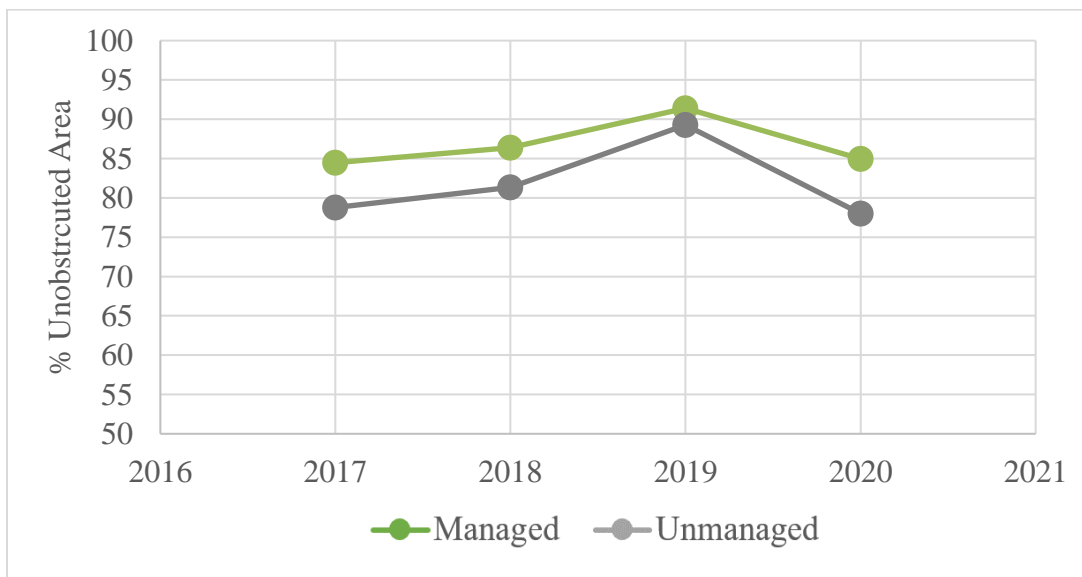
**Figure 24.** Percent unobstructed area in main channel areas managed to reduce in-channel vegetation (managed) and other areas (unmanaged).

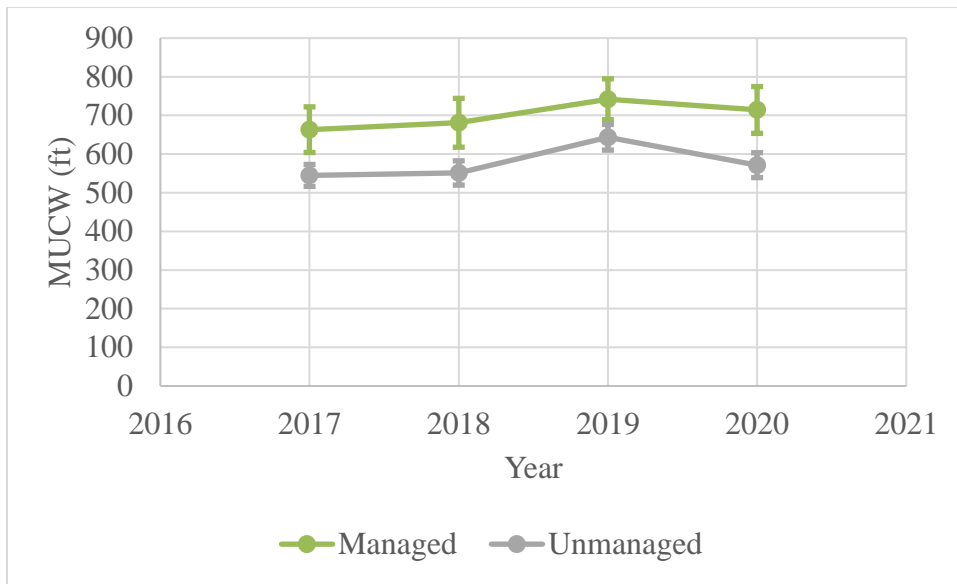
**Figure 25.** MUCW means (points) and standard errors (bars) of in main channel areas managed to reduce in-channel vegetation (managed) and other areas (unmanaged).

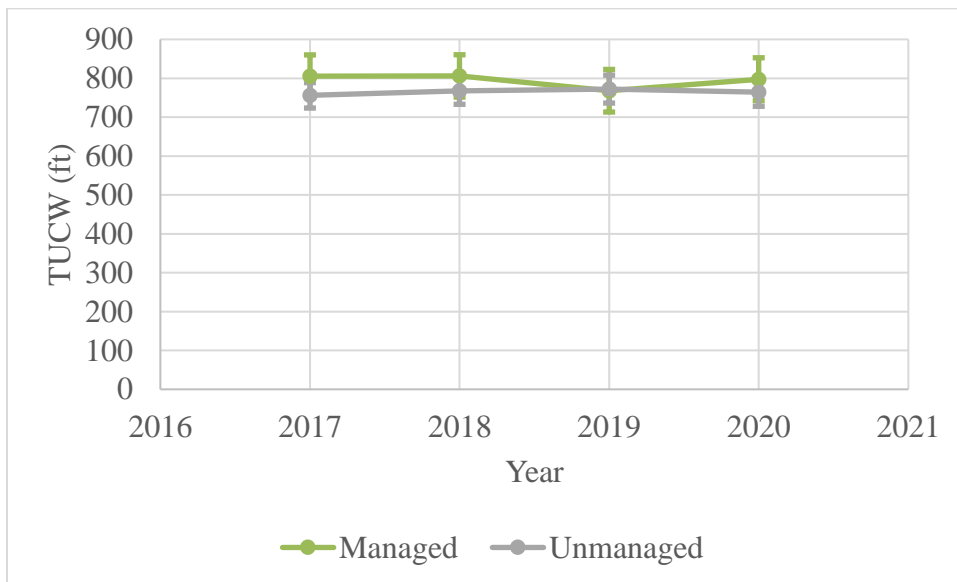
**Figure 26.** TUCW means (points) and standard errors (bars) in main channel areas managed to reduce in-channel vegetation (managed) and other areas (unmanaged).

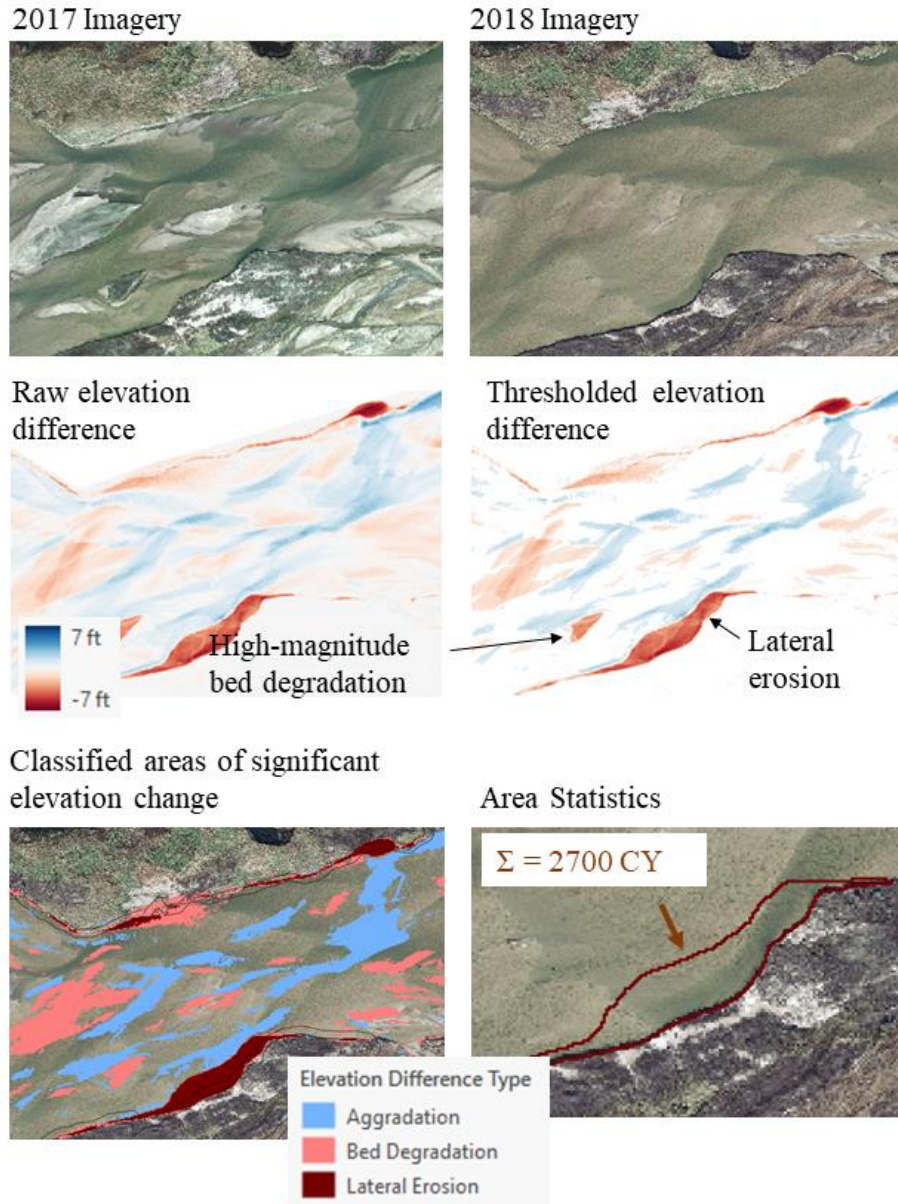
**Figure 27.** Conceptual diagram outlining how elevation values of two years are differenced, thresholded based on probability, classified by difference type, and analyzed spatially.

Aggradation and bed degradation represent low-magnitude positive and negative elevation differences typically associated with the migration of sandbars. An area with bed degradation that outpaces aggradation may be incising. Lateral erosion represents large-scale negative elevation changes near the channel banks and on the margins of established islands. High levels of lateral erosion are an indication of channel widening. For this analysis, lateral erosion areas were classified as areas along channel/bar/island margins (within 20 ft of the modeled 5,000 cfs flow extent) with an elevation difference less than or equal to -2 ft. Areas of bed degradation were classified as all remaining significantly negative areas.

Net bed volume change was subsequently calculated by subtracting the magnitude of bed degradation from aggradation. Lateral erosion is not included in the net bed volume change calculation, because it is a measure of channel bank change rather than channel bed change.

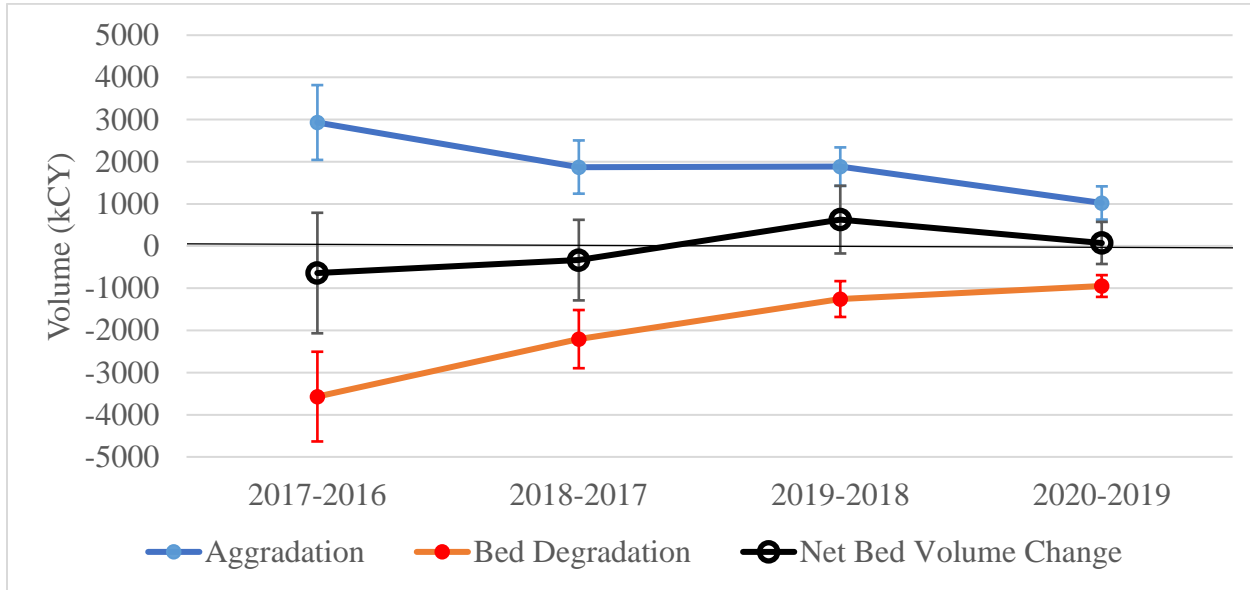
**Figure 28.** Total volumes of significant elevation change (points), and error (bars), classified as either aggradation or bed degradation, with net bed volume change, for all channels from Overton to Chapman.

The AHR net sediment balance analysis indicates that 2017-2020 was a period of relative stability (Figure 28). The net volume change estimates were negative for all analysis years except 2019-2018, though the confidence interval for all years crossed 0, indicating that no year in this period was either significantly net aggradational or degradational.

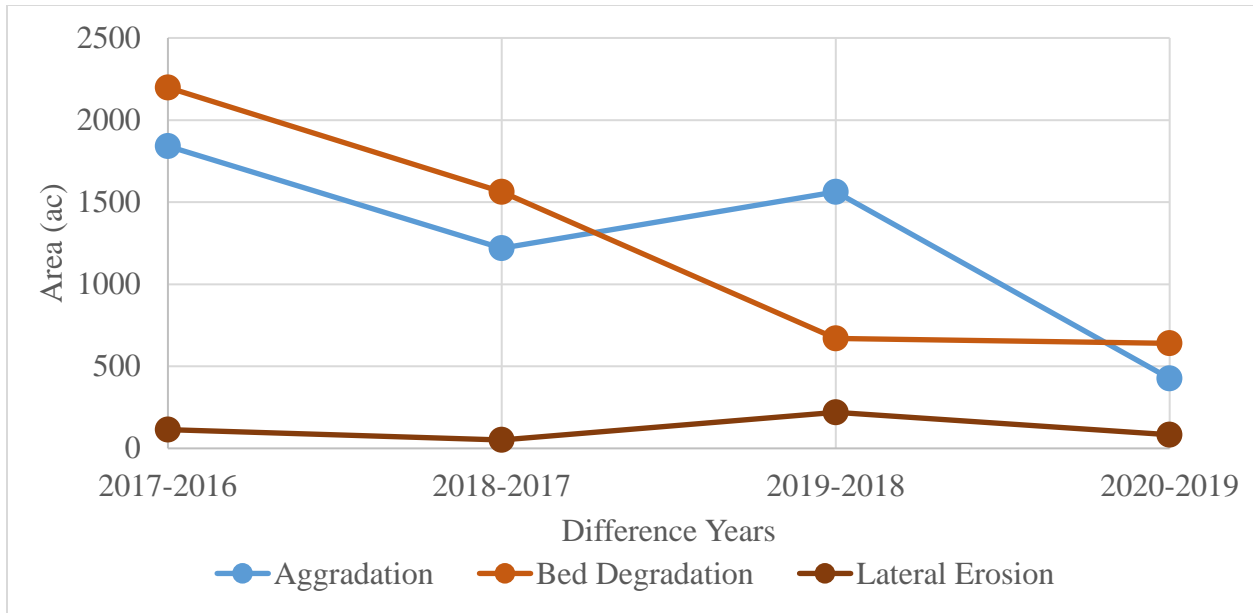
**Figure 29.** Total area of significant elevation change classified as either aggradation, bed degradation, or lateral erosion between years. These values represent all channels from Overton to Chapman.
