# Platte River Recovery Implementation Program (PRRIP)

## SYSTEM-SCALE GEOMORPHOLOGY AND VEGETATION MONITORING REPORT

2017 - 2020

**Prepared for: PRRIP Governance Committee**

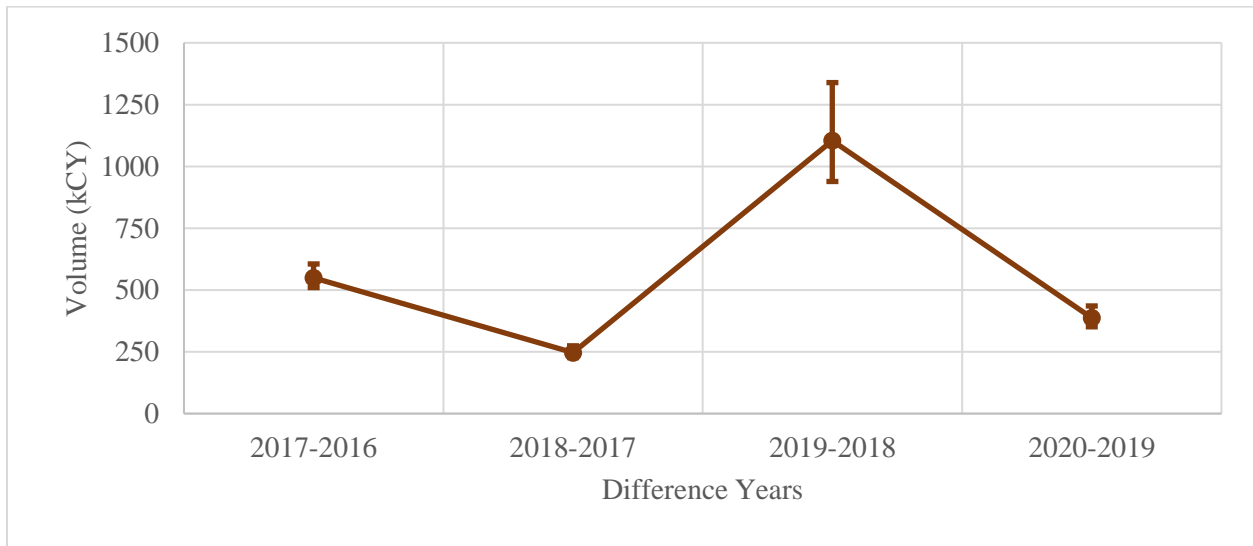
**Figure 30.** Total volume of lateral erosion (points) with estimated error (bars) by year. These values represent all channels from Overton to Chapman.

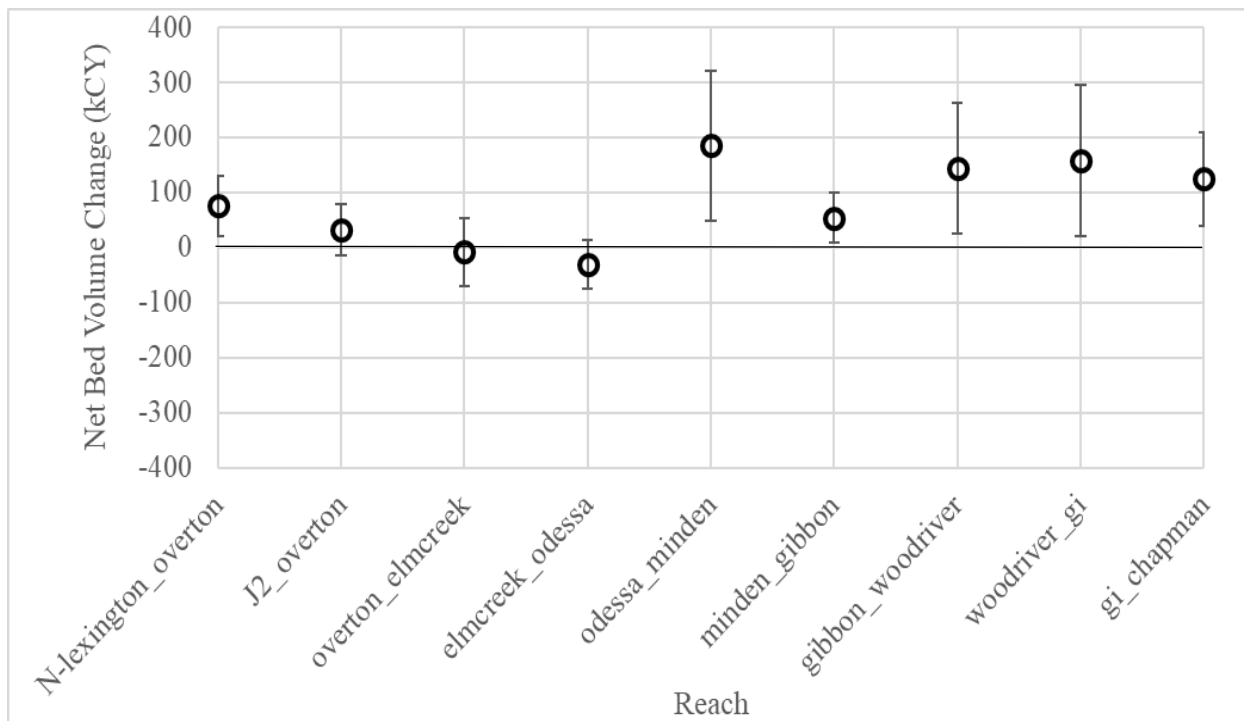
**Figure 31.** Net channel bed volume change estimates (points) and estimated error (bars) for all channels by reach, 2019-2018.

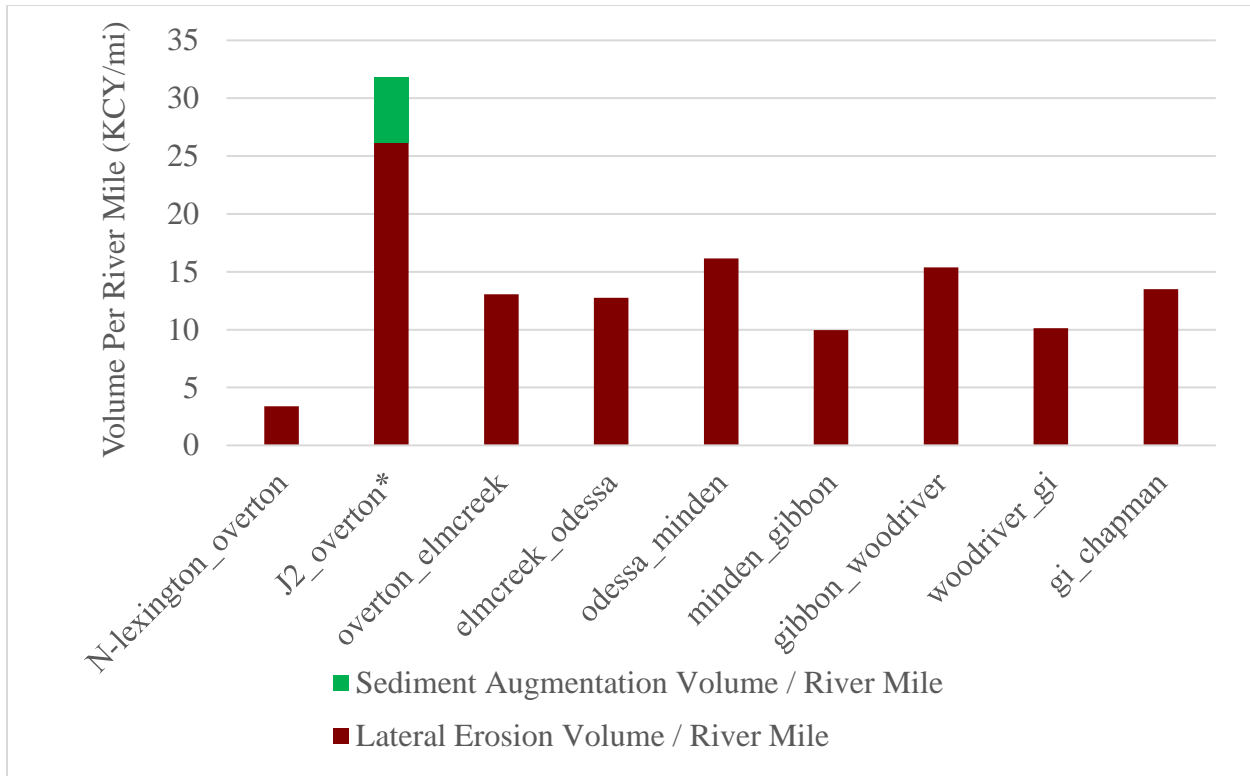
**Figure 32.** Lateral erosion volume by geomorphic reach for all channels for the analysis period 2019-2018. \*Sediment augmentation in the J2 Return to Overton reach is subtracted from the classified lateral erosion volume, and reported separately.

The high rate of lateral erosion in the J2 Return to Overton reach is likely due to a combination of reach slope and hydrology, which is dominated by the clearwater hydropower return flows from the J2 Canal. Sediment-starved water entering the channel at the J2 Return has resulted in high rates of bed degradation in the reach, which has in turn reduced channel slope. Much of the upper portion of the reach with reduced slope has transitioned from a braided planform to a single-thread wandering planform that meanders back and forth across the incised channel section, laterally eroding floodplain terraces along the outside of bends.

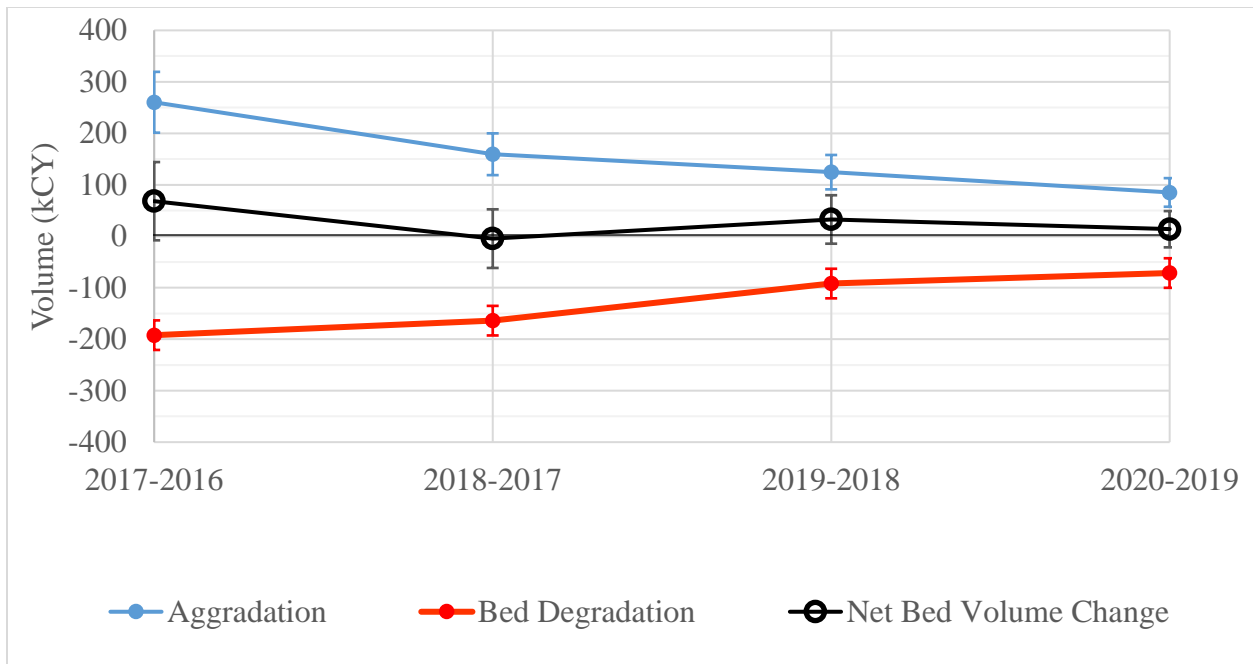
**Figure 33.** Total volumes of significant elevation change (points), and error (bars), classified as either aggradation or bed degradation, with net bed volume change, for the J2 Return to Overton reach.

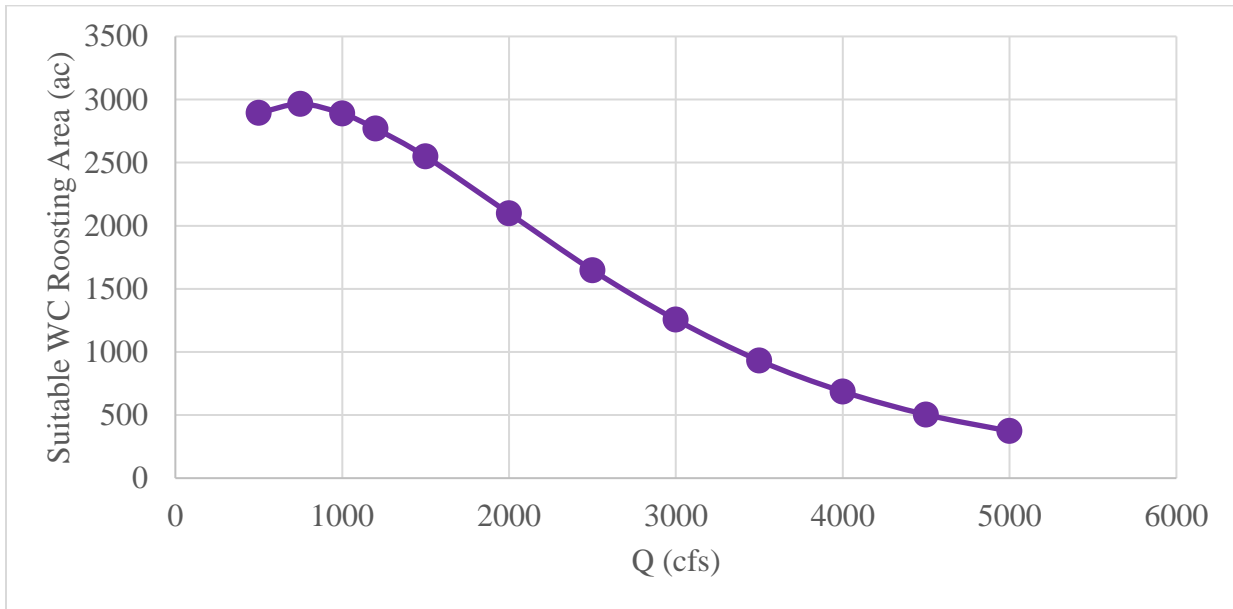
**Figure 35.** Suitable whooping crane roosting area in the AHR by modeled flow, for all channels in 2020.

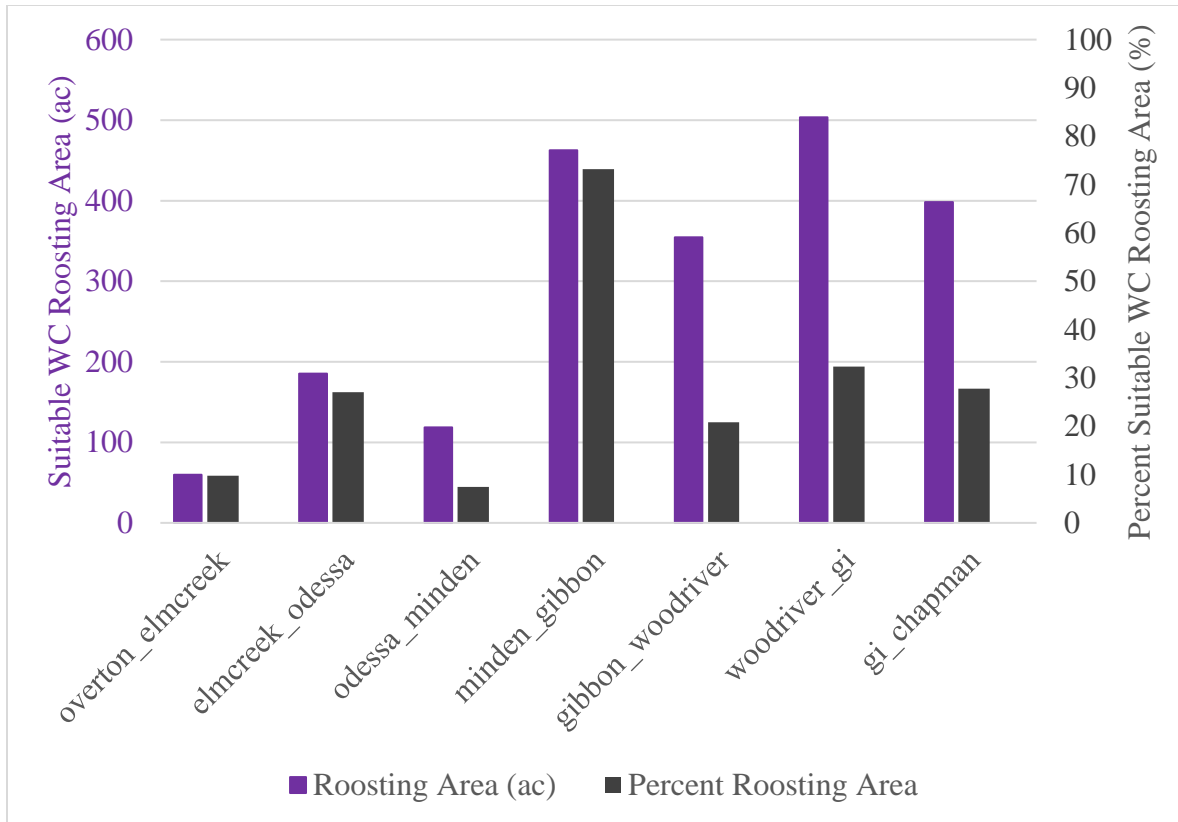
**Figure 36.** Absolute and percent suitable roosting area by geomorphic reach for the main channel, modeled at 2000 cfs with 2020 data.

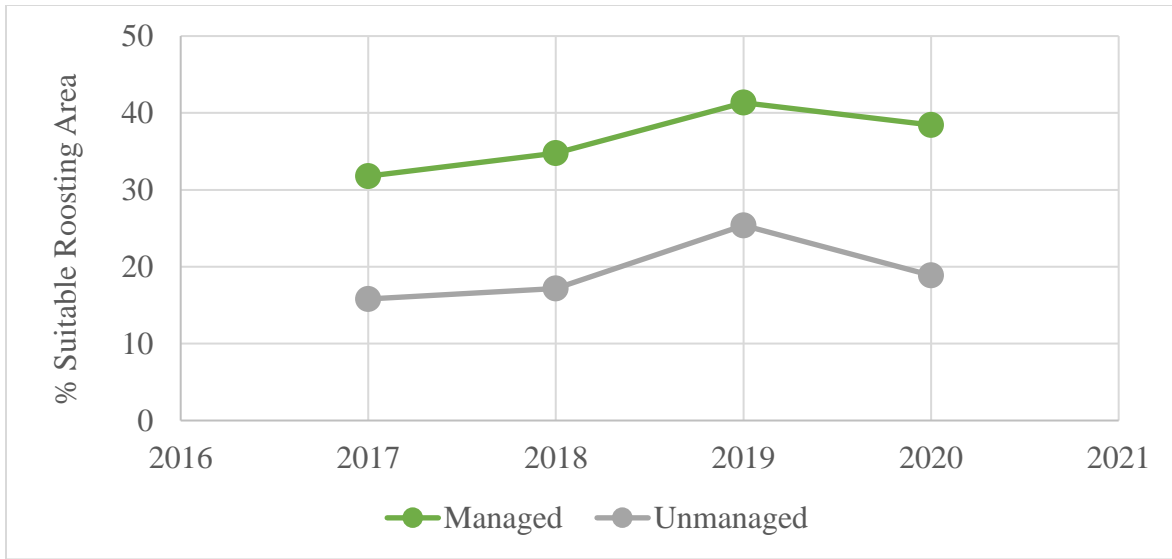
**Figure 37.** Percent suitable roosting area at 2000 cfs over time for managed areas vs. unmanaged areas of the main channel.

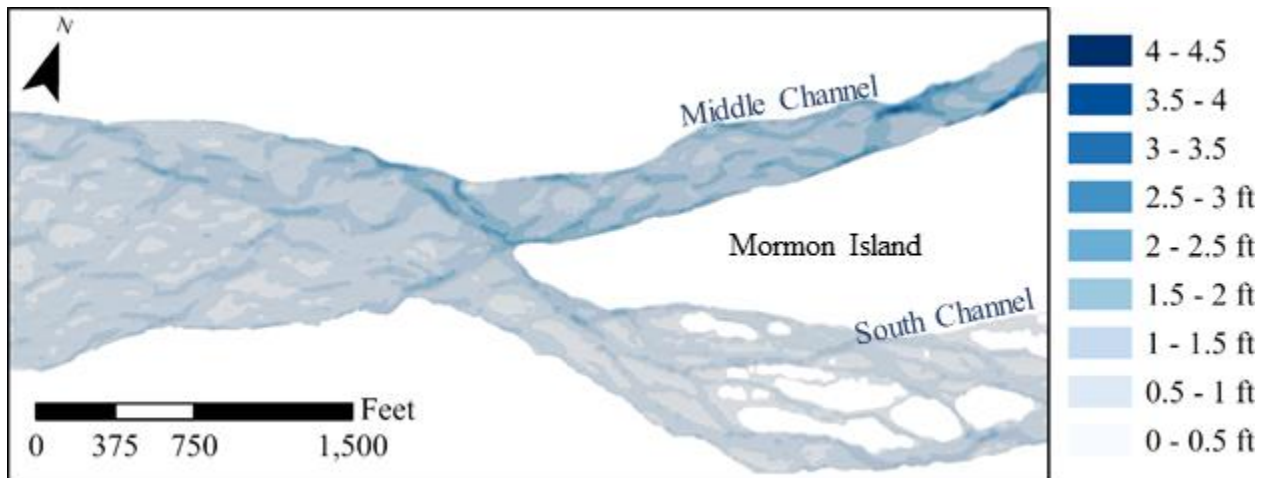
**Figure 39.** Model flow depths (2020) at 2,000 cfs. Flow is substantially deeper in the middle channel than the south channel, which historically carried the majority of flow around the south side of Mormon Island.

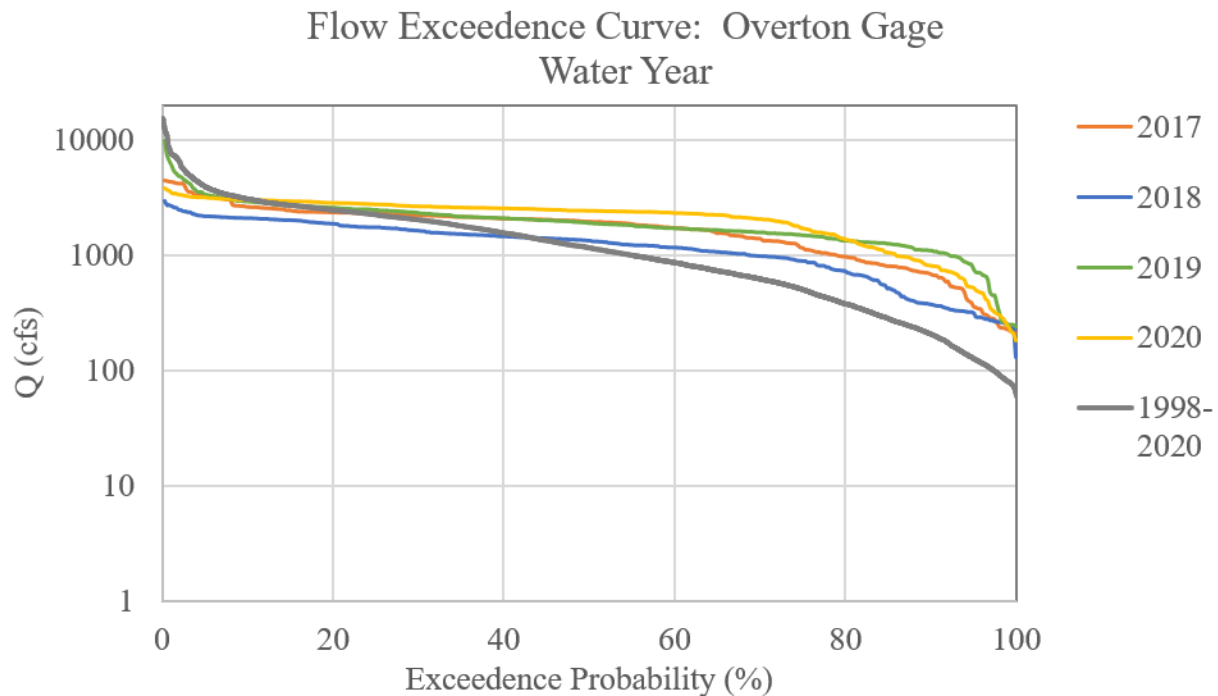
**Fig. C1.** Flow Exceedence curves for each water year from 2017-2020, as well as the period from 1998-2020, developed from the mean daily data from the USGS Overton gage (06768000).

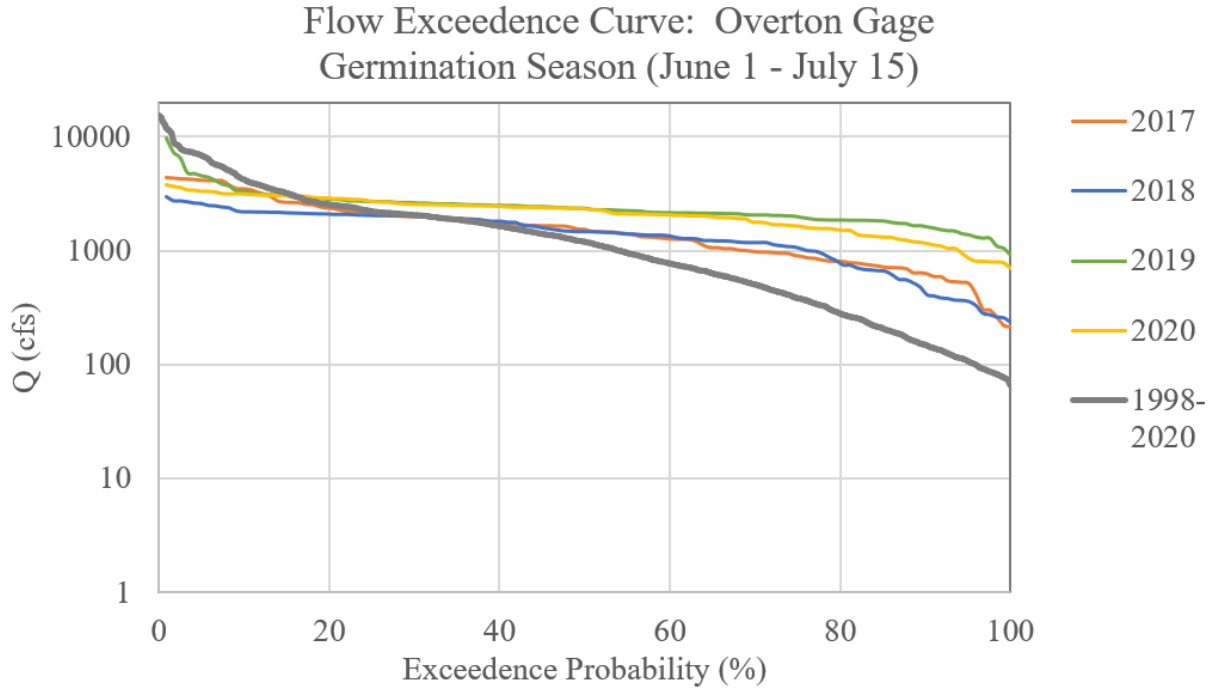
**Fig. C2.** Flow Exceedance curves for the germination season of each water year from 2017-2020, as well as the period from 1998-2020, developed from the mean daily data from the USGS Overton gage (06768000).

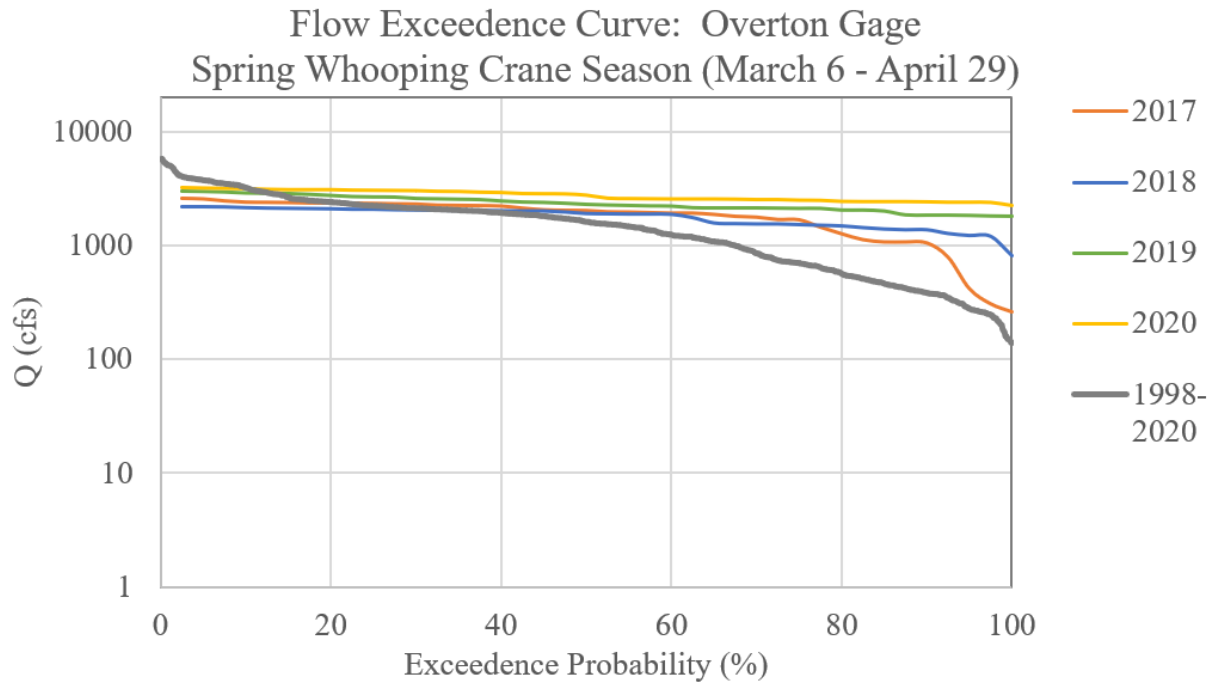
**Fig. C3.** Flow Exceedance curves for the spring whooping crane migration season of each water year from 2017-2020, as well as the period from 1998-2020, developed from the mean daily data from the USGS Overton gage (06768000).

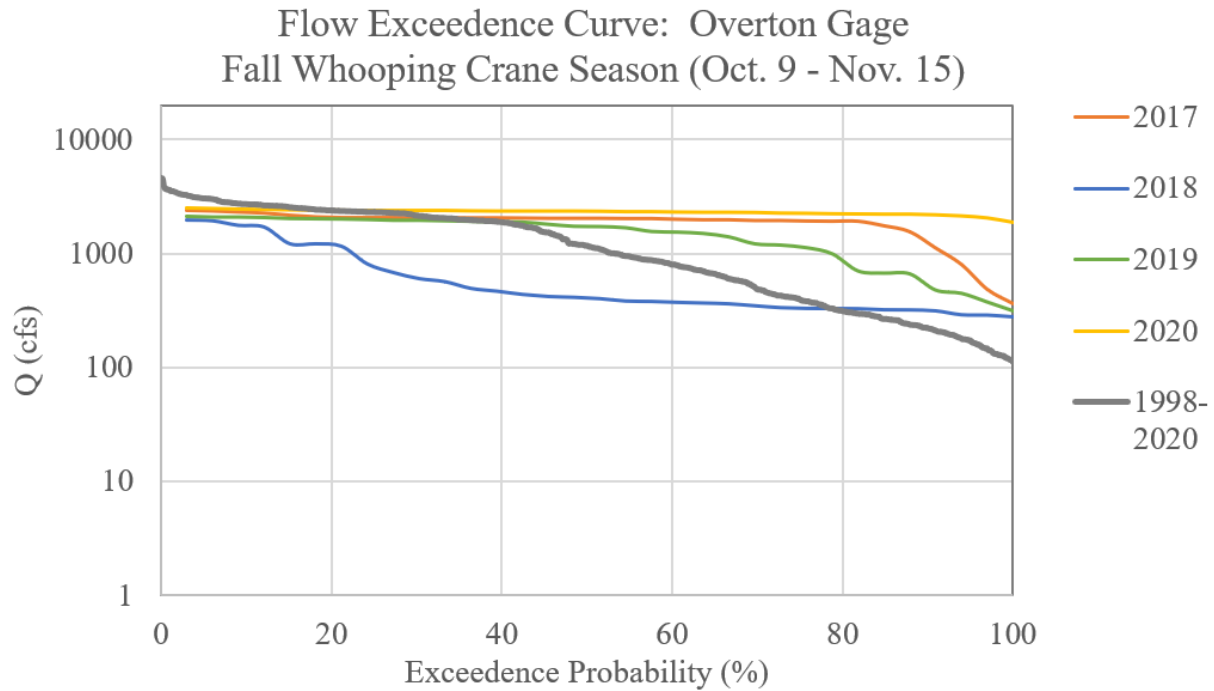
**Fig. C4.** Flow Exceedence curves for the fall whooping crane migration season of each water year from 2017-2020, as well as the period from 1998-2020, developed from the mean daily data from the USGS Overton gage (06768000).

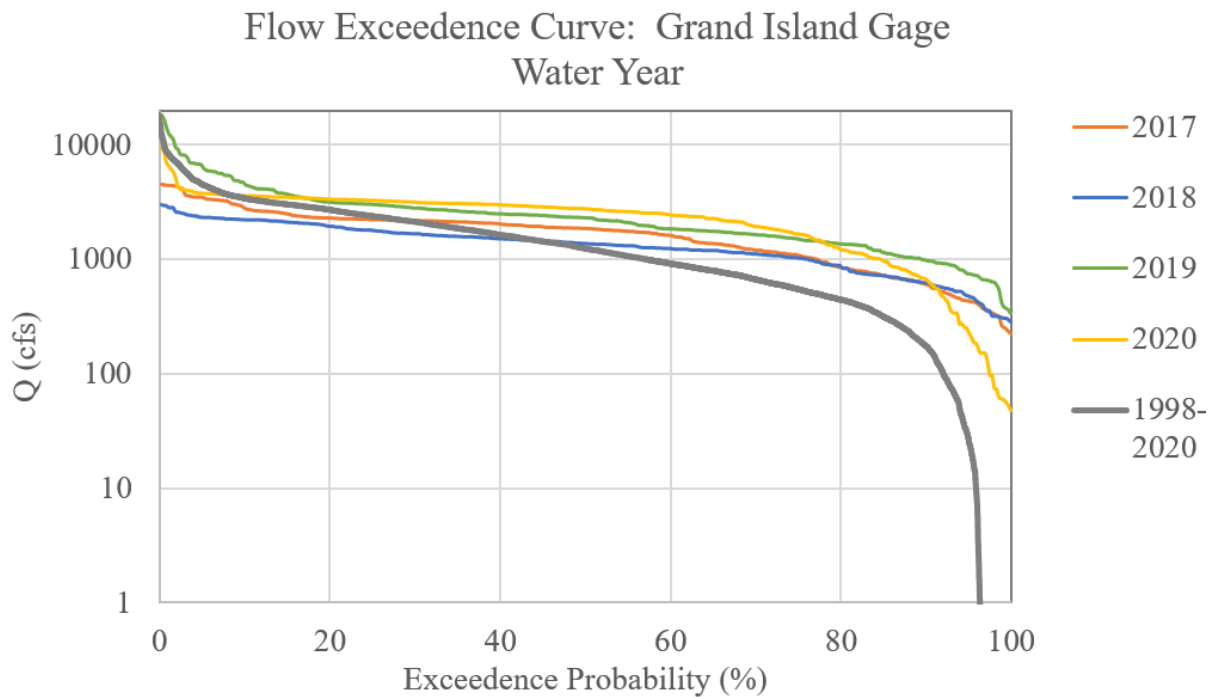
**Fig. C5.** Flow Exceedence curves for each water year from 2017-2020, as well as the period from 1998-2020, developed from the mean daily data from the USGS Grand Island gage (06770500).

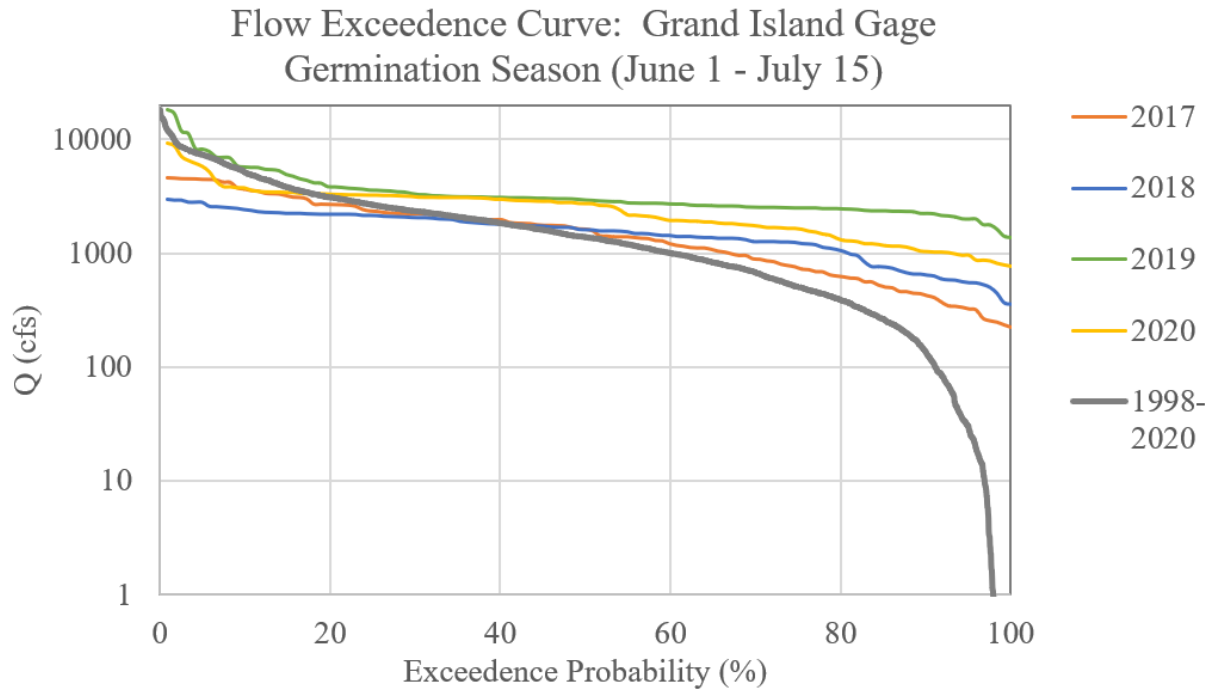
**Fig. C6.** Flow Exceedence curves for the germination season of each water year from 2017-2020, as well as the period from 1998-2020, developed from the mean daily data from the USGS Grand Island gage (06770500).

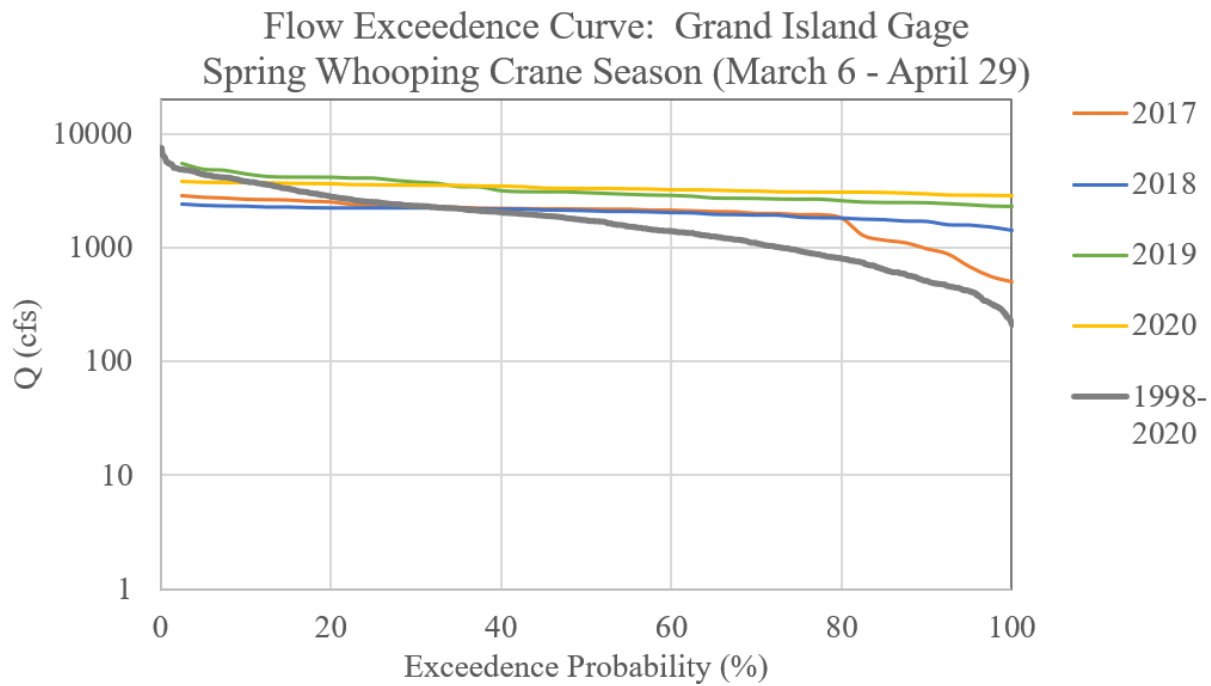
**Fig. C7.** Flow Exceedence curves for the spring whooping crane season of each water year from 2017-2020, as well as the period from 1998-2020, developed from the mean daily data from the USGS Grand Island gage (06770500).

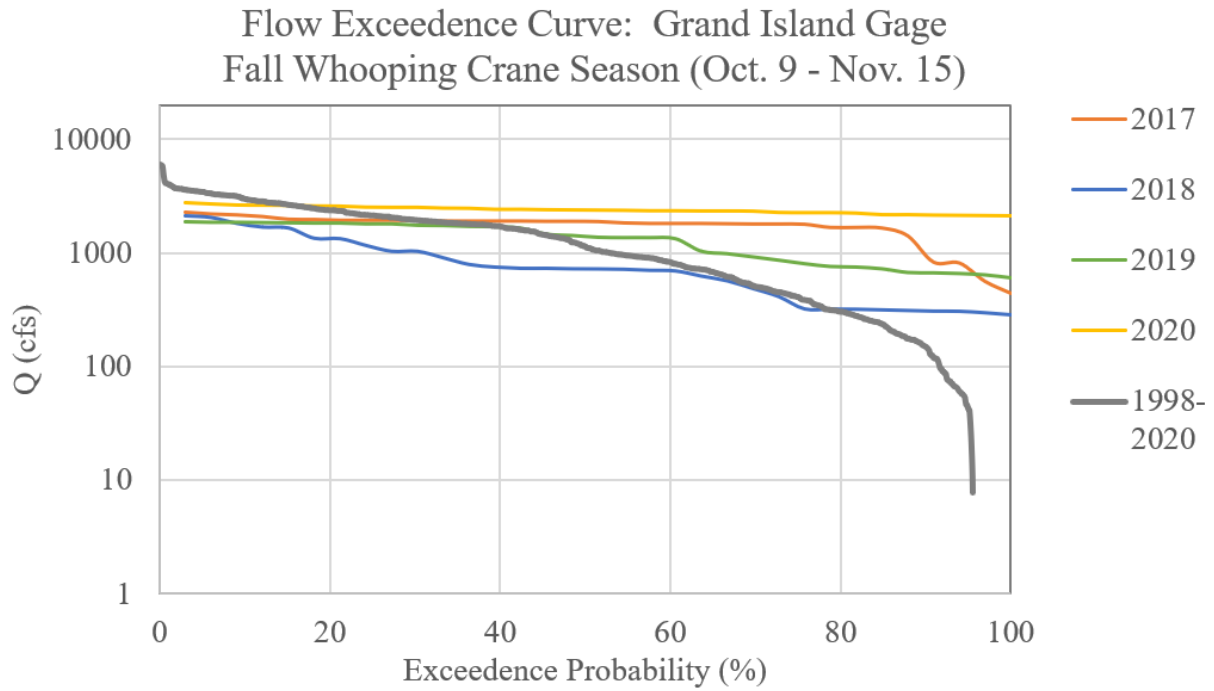
**Fig. C8.** Flow Exceedence curves for the fall whooping crane season of each water year from 2017-2020, as well as the period from 1998-2020, developed from the mean daily data from the USGS Grand Island gage (06770500).
